# ACTION PLAN ENVIRONMENTAL REMEDIATION IN AND AROUND UCIL, BHOPAL

EXPERT ROUNDTABLE, APRIL 25-26, 2013

CENTRE FOR SCIENCE AND ENVIRONMENT

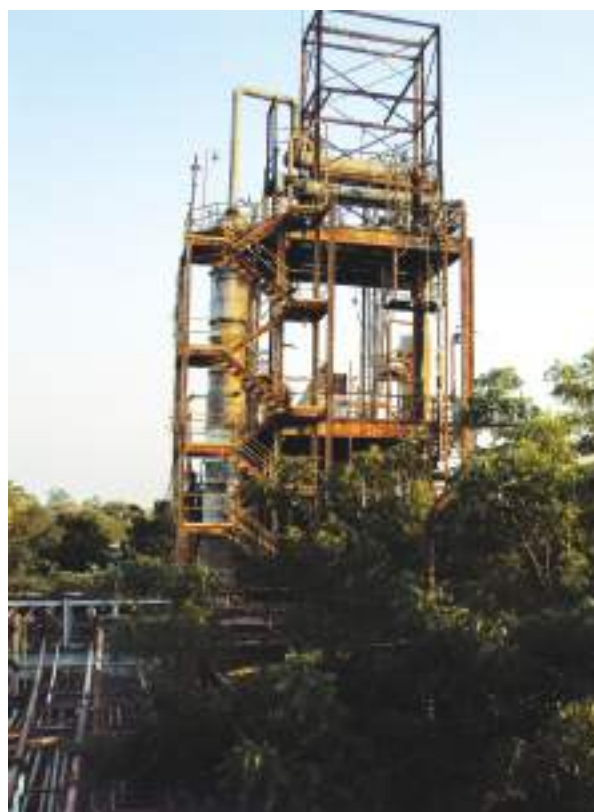
Plant structure at UCIL, 2009

The survey found broken boundary walls at many places and dilapidated plant, machineries and buildings. Several dumps were present. SEP and an abandoned landfill was found damaged. The study also noted that the excavation of dumps done earlier by M/s. Ramky Limited was incomplete. Three out of the nine suspected dump sites were assessed for contamination.

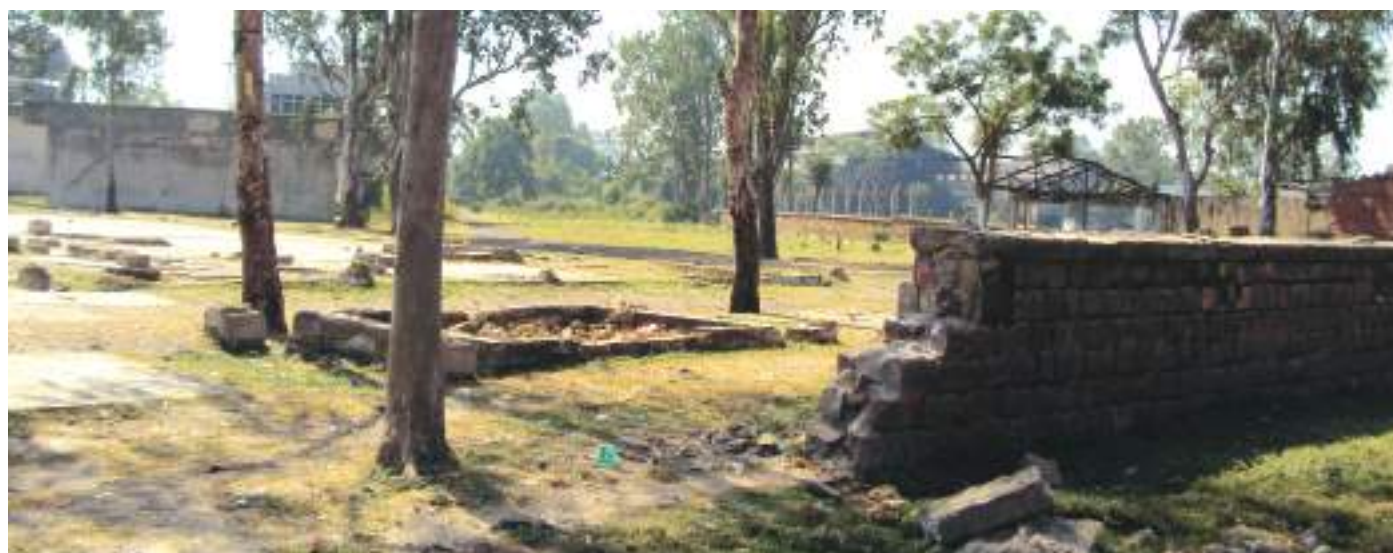
Broken boundary wall at UCIL, 2009

Repeatedly broken boundary walls of the UCIL site and lack of security personnel provides uninterrupted access to local people. Considering the presence of toxic waste, dump sites and contaminated machinery, this is a cause of serious health concern, particularly for children, who are found playing in the premises.

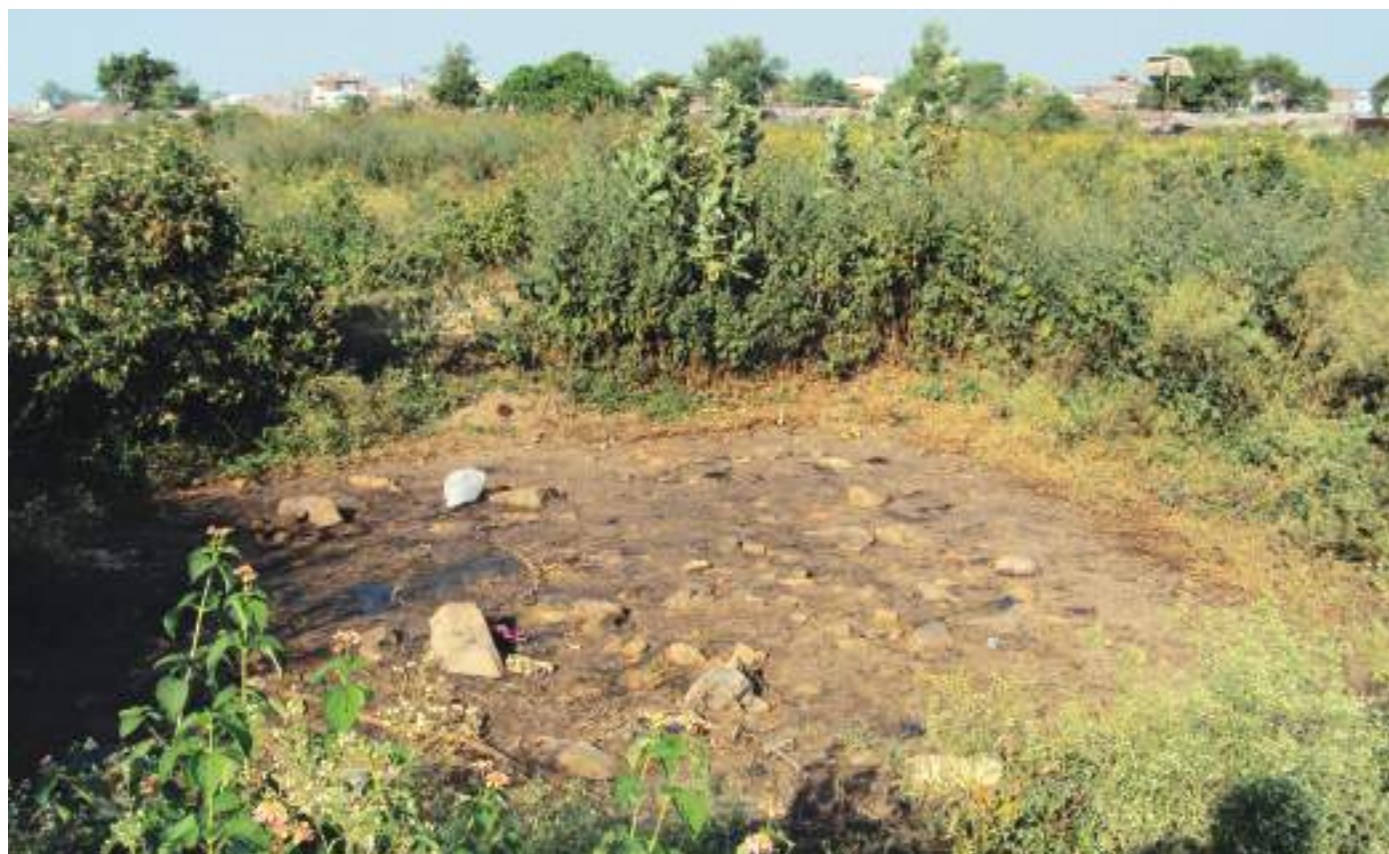
**Waste dump site at UCIL, 2009**

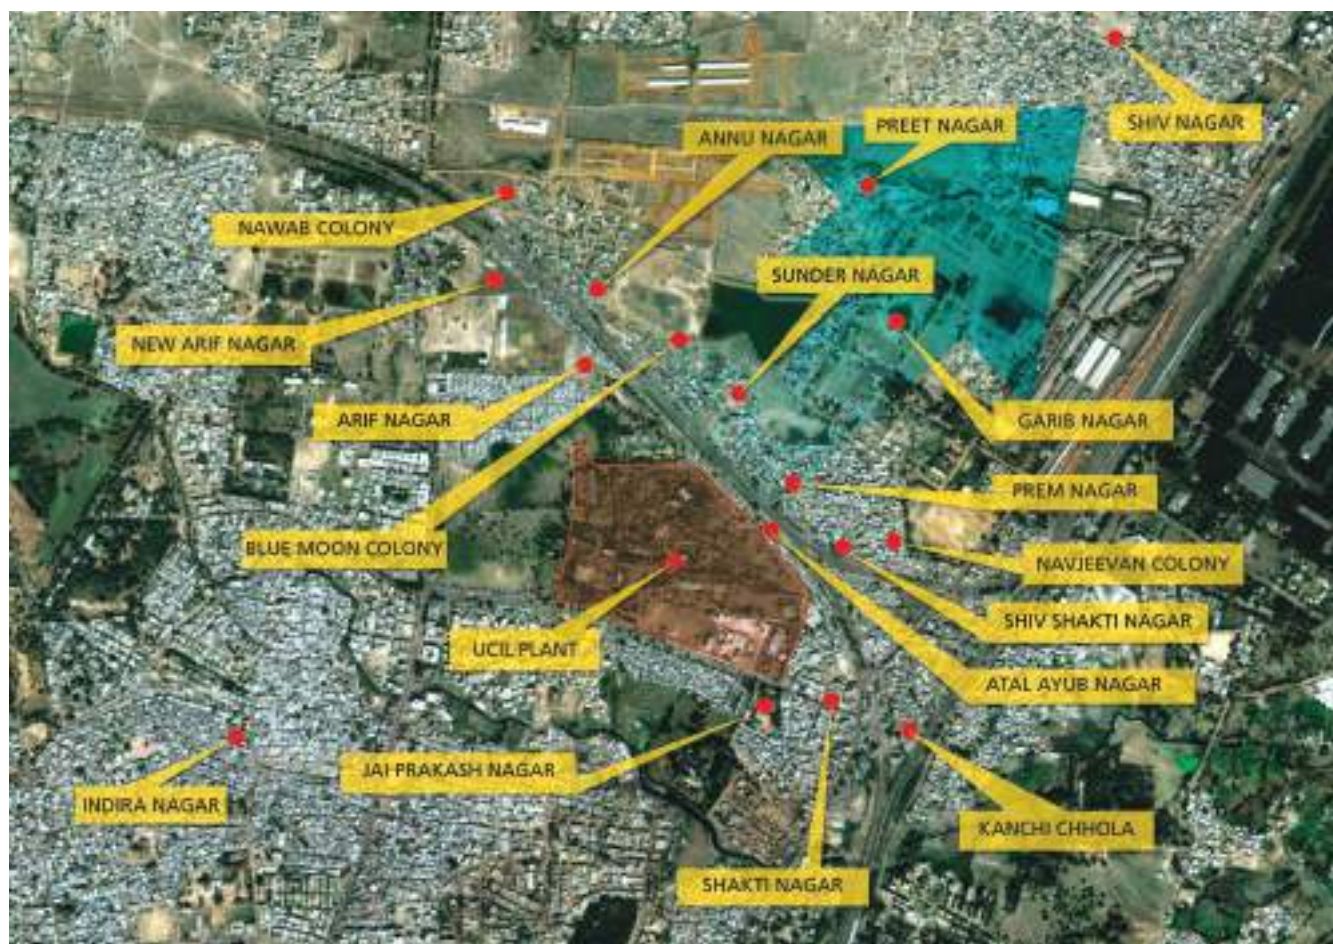
**Figure 2** Areas around UCIL – Contaminants tested and found in groundwater

A large number of contaminated areas were found to be near the railway line that passes through the north of the UCIL site. The reported direction of groundwater flow is in similar direction, i.e. towards north-east. In one study, a sample from Shiv Nagar, which is about three kms from the UCIL site, was found to be contaminated (see Figure 2: *Areas around UCIL*

Most of the studies confirmed groundwater contamination with organic contaminants. The contamination is found more towards the reported direction of the groundwater flow, i.e. north-east

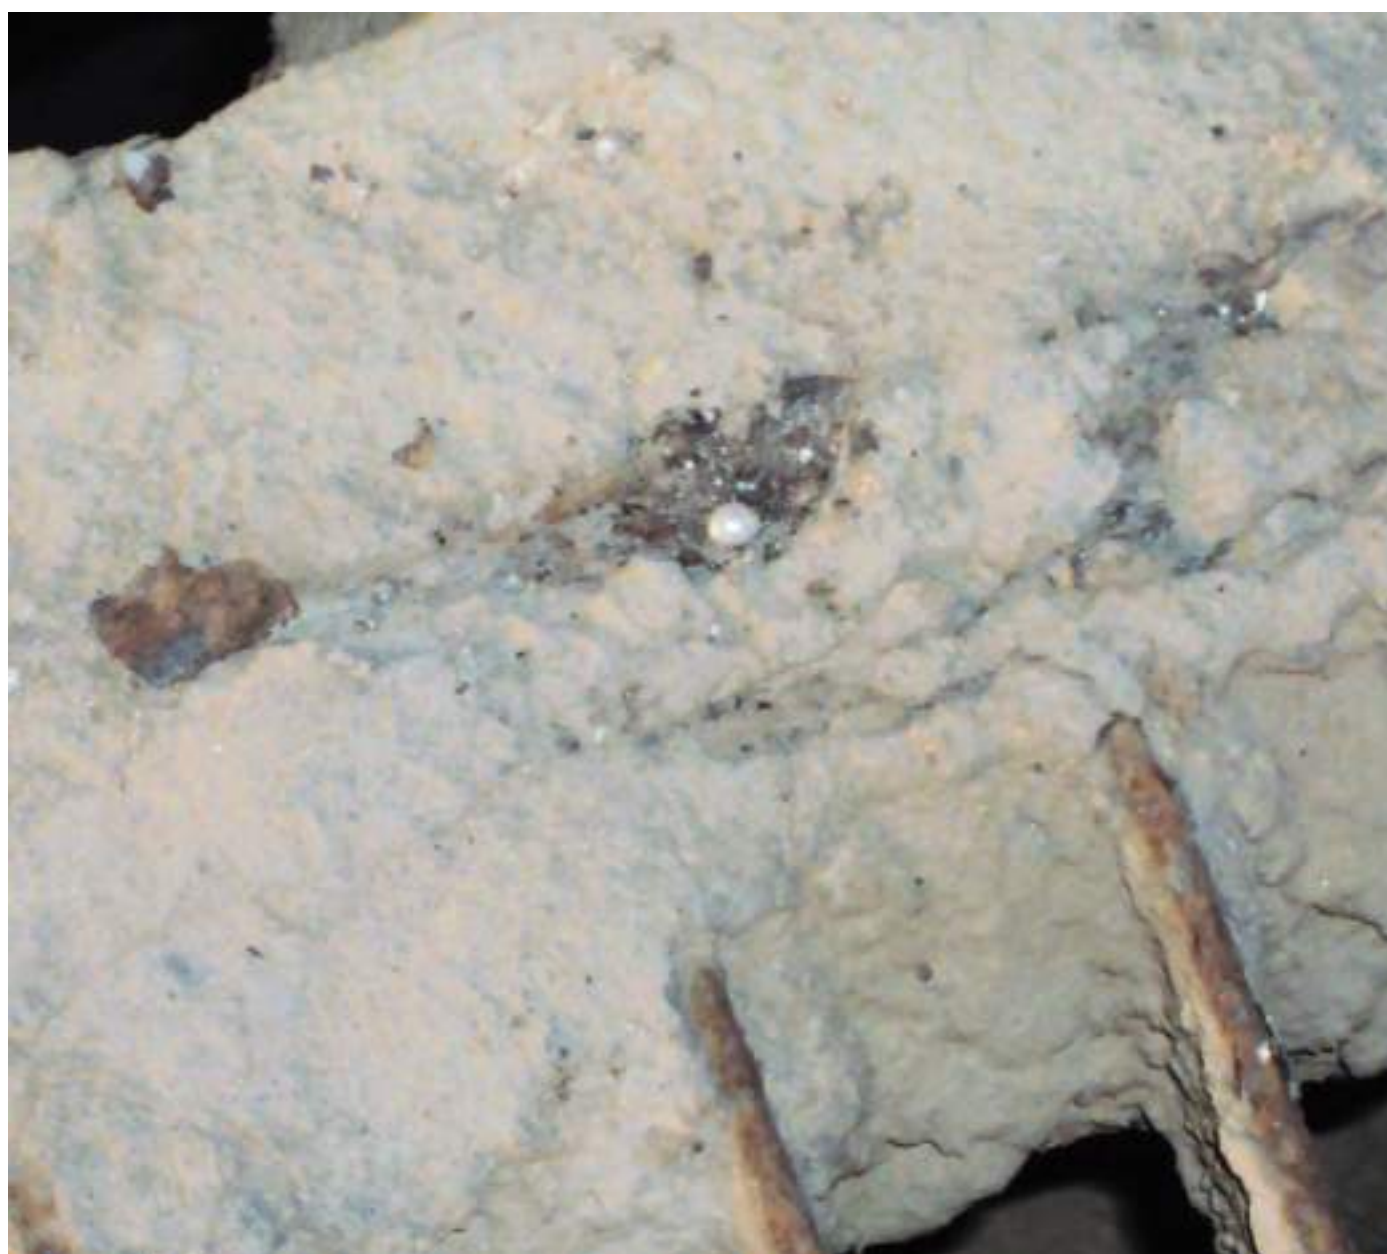
Mercury found at UCIL, 2009

Mercury was used as a sealant in the sevin plant and chromium was used as a coolant in the cooling plant at the UCIL.

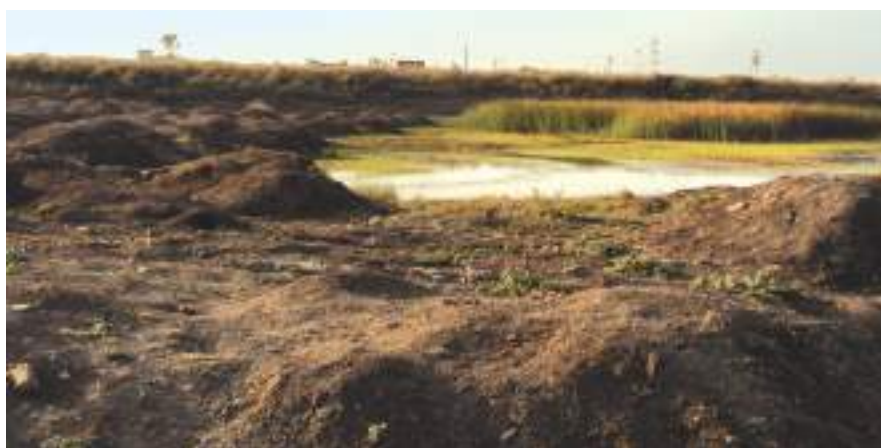
Solar evaporation pond area, 2009

The SEP area lies at the north of the UCIL site. In mid 1990s, waste from two ponds was excavated and dumped into the third pond (secured landfill), the liners of which were found to be damaged/removed in subsequent studies.

Waste dumped at the landfill in the SEP is to be characterised, followed by an assessment and development of a basket of suitable options. The landfill is damaged and this waste could be recovered and stored in a temporary storage within the UCIL site considering the need to estimate the volume and nature of waste. Moreover, the SEP area is to be secured and made inaccessible to local community.

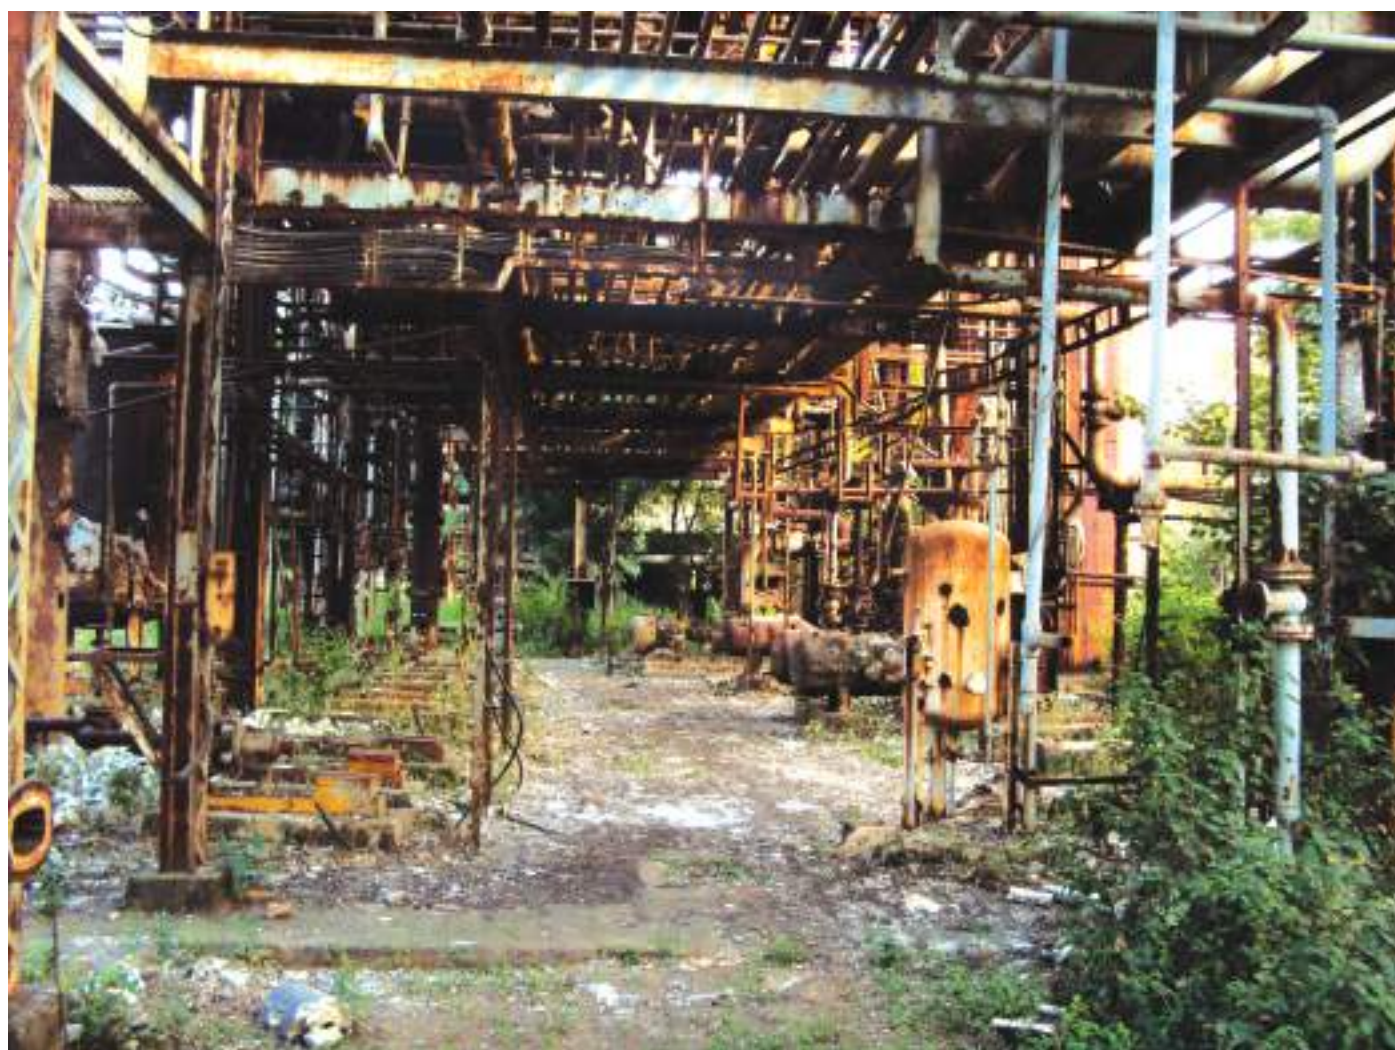
Plant machinery at UCIL, 2009

The report proposed dismantling after in-situ detoxification. The dismantling as proposed is to begin with pipelines followed by the equipments and finally the structure. It should initiate from top floor and proceed to the ground floor and involve suitable cutting of the columns and beams into small sections. Broken and completely corroded equipment and pipelines are suggested to be removed and directly soaked in an alkali pit for detoxification.

Decommissioning is also proposed but only after detoxification. As suggested, it should be done by cutting components into pieces to make them unfit for reuse.

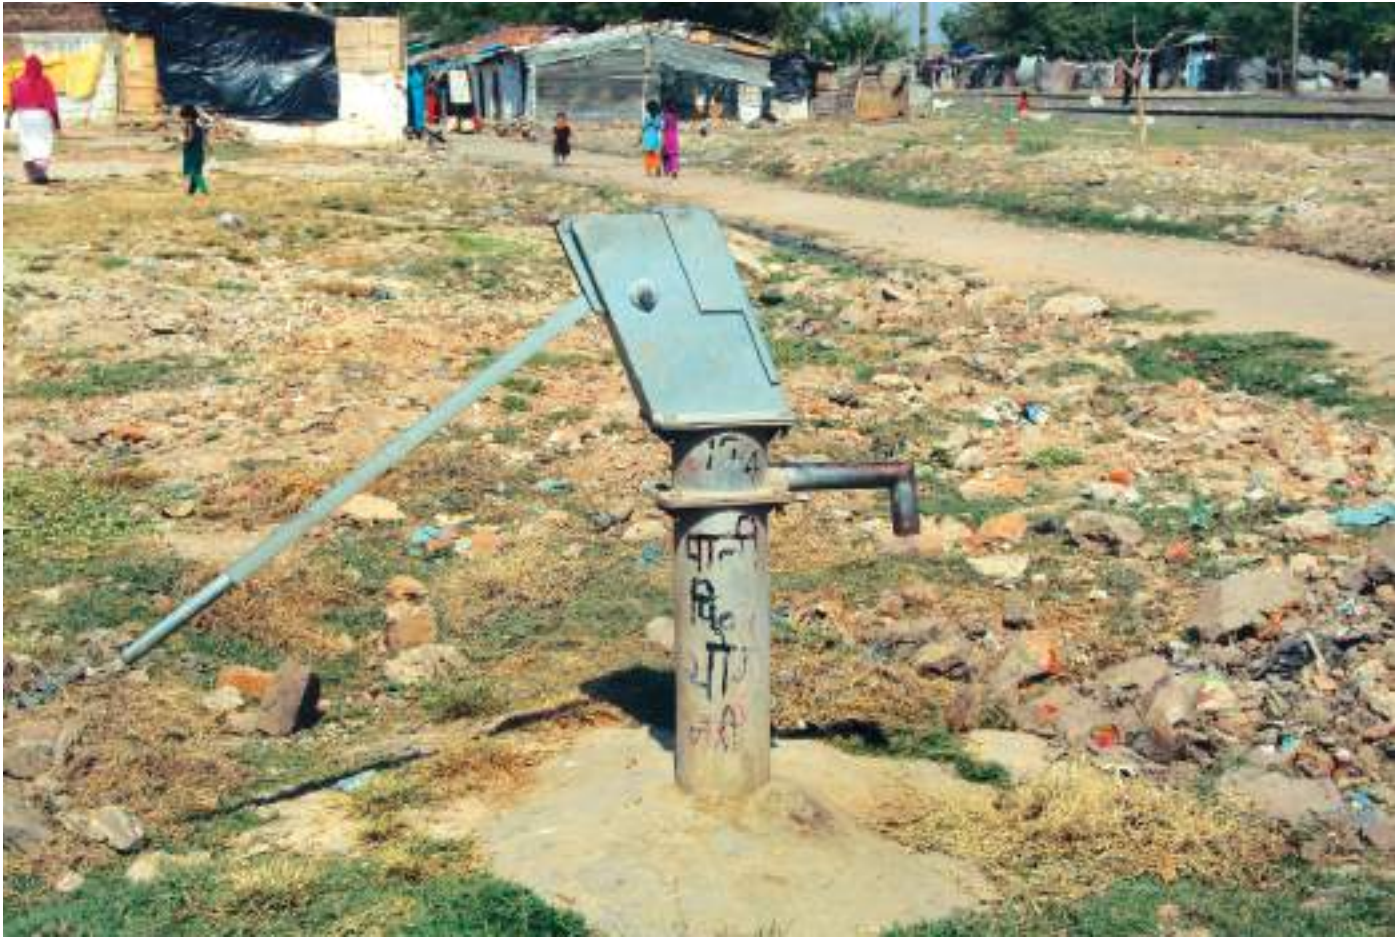
Contaminated water source near railway line (North of UCIL), 2009

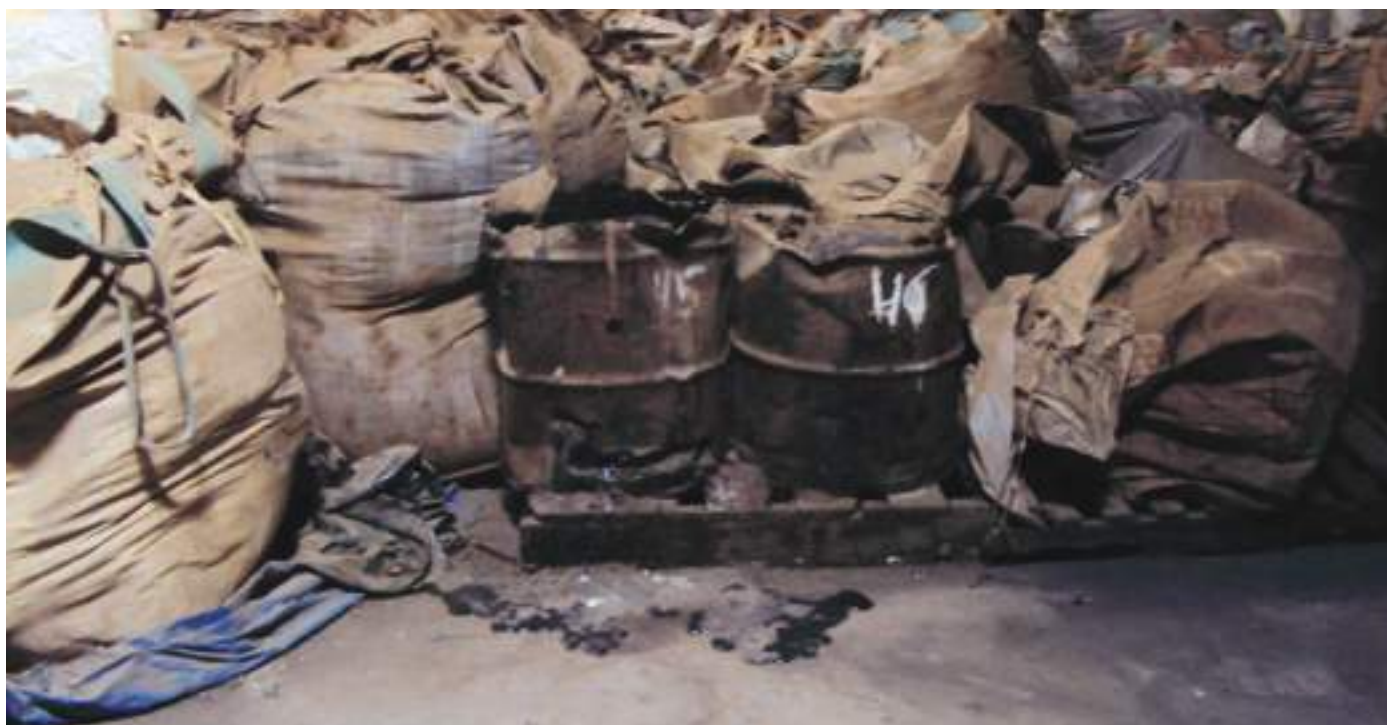
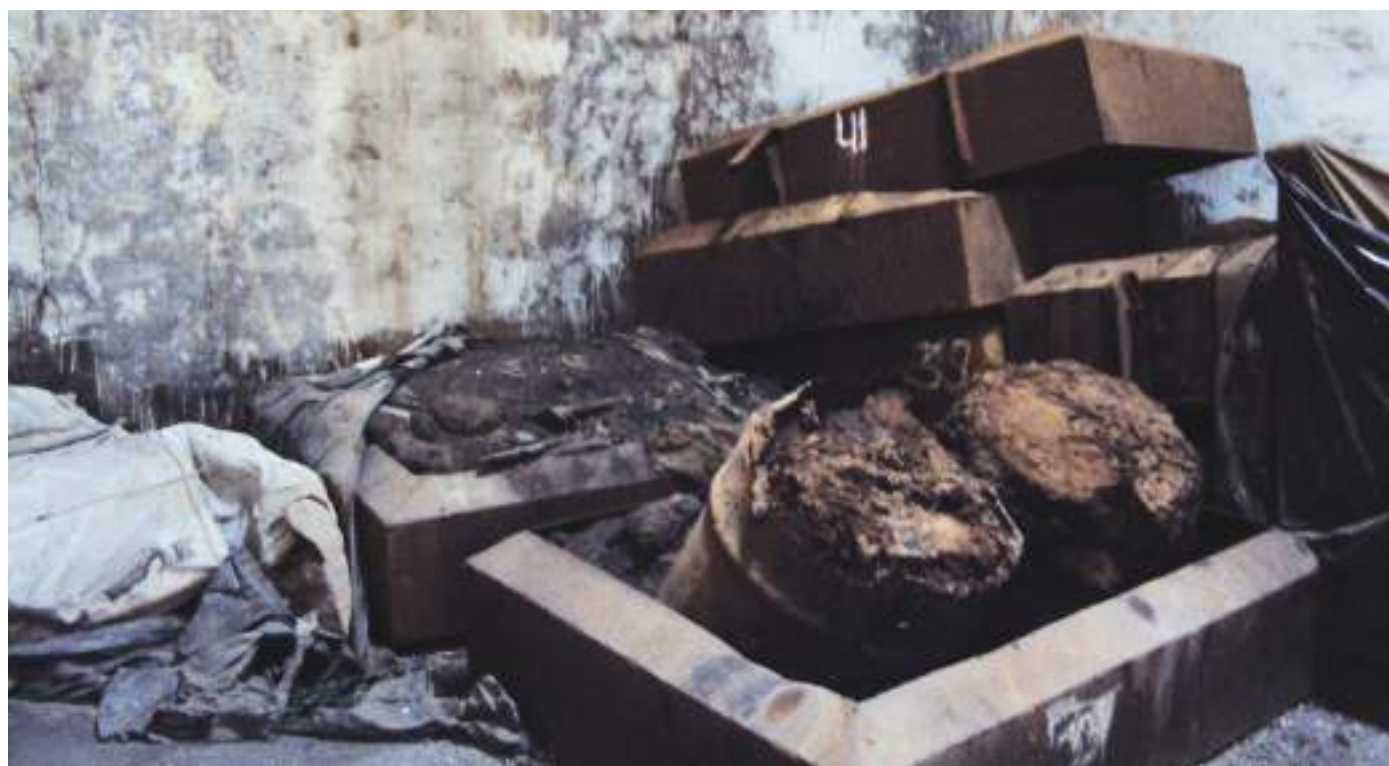
Waste packed and stored at UCIL, 2009

There was a lack of clarity about the volume and constituents of the waste that has been packed and kept at the site. It was finally agreed that as of now, the packed waste amounts to about 350 tonnes (see Table 6: *Contents of packed waste at UCIL*). Besides presence of 164 tonnes of excavated soil, the reported segregation of overall constituents was found to be varying to a certain extent and leading to a confusion. Considering the volume of the excavated soil, it was deemed necessary to characterise it before incineration. It was also agreed that whatever data is available on characterisation of this waste, particularly the excavated soil, should be made public and further characterisation is to be done if required.

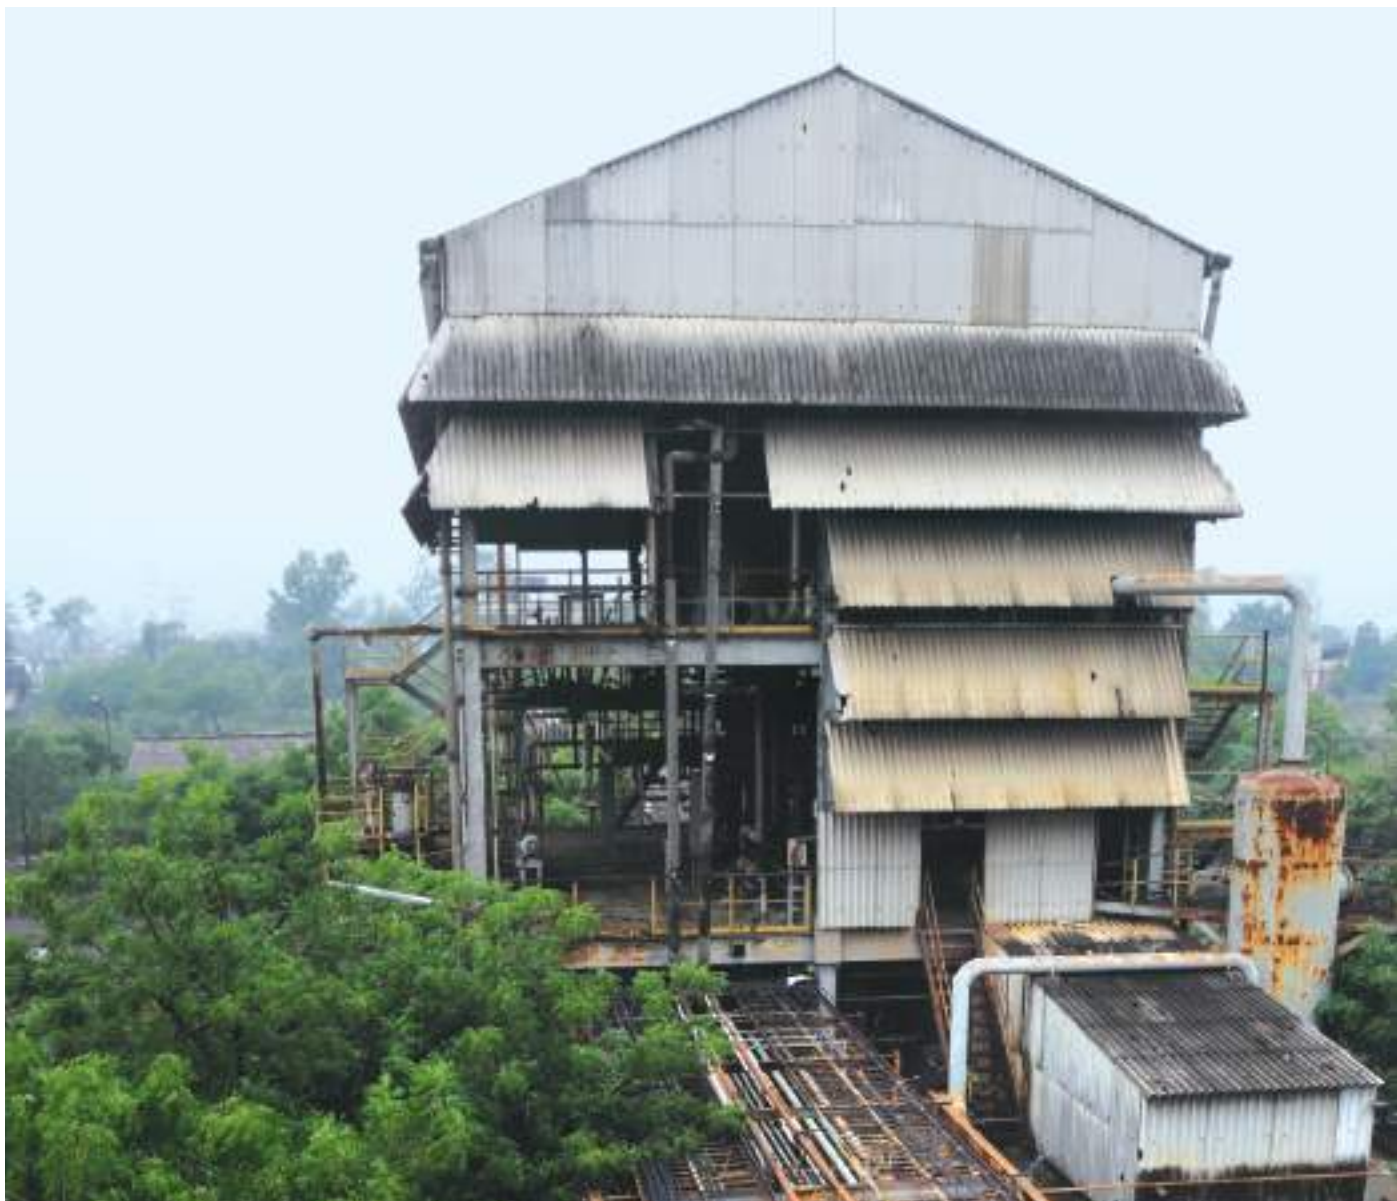
Plant structure at UCIL, 2009

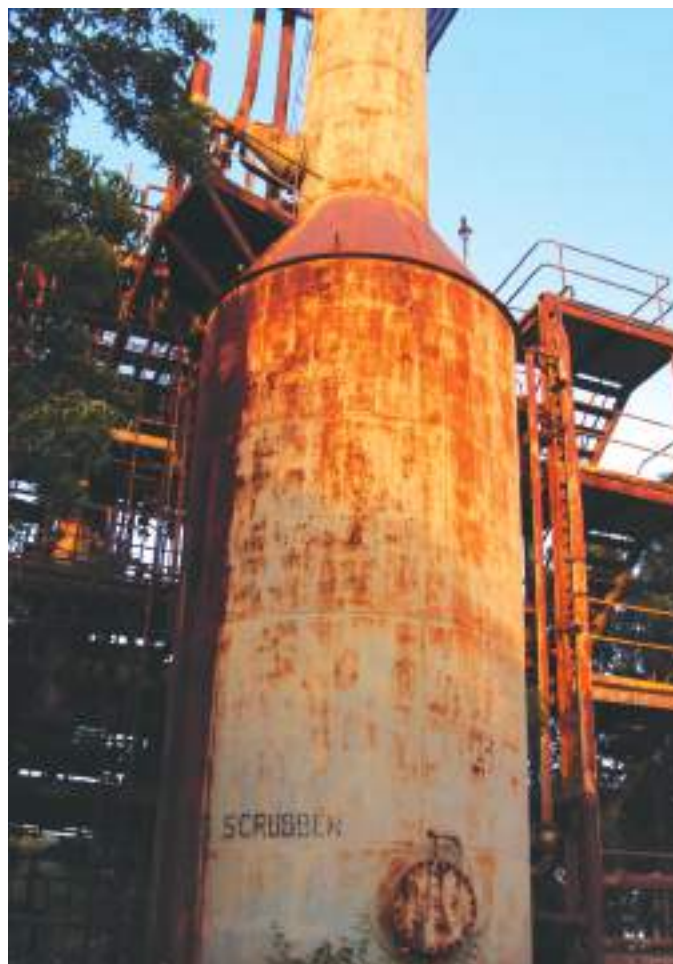
*Vent gas scrubber, 2009*

It came out during the discussion that these parts of the plant are relatively in better condition. It was a consensus to preserve these as part of a memorial after decontamination as suggested by IICT.
