**Final Report**

**Assessment and Remediation of Hazardous Waste  
Contaminated Areas in and around M/s Union  
Carbide India Ltd., Bhopal**

**Bhopal Gas Tragedy Relief and Rehabilitation Department  
Govt. of Madhya Pradesh, Bhopal**

**National Environmental Engineering Research Institute  
Nehru Marg, Nagpur - 440020  
([www.neeri.res.in](http://www.neeri.res.in))**

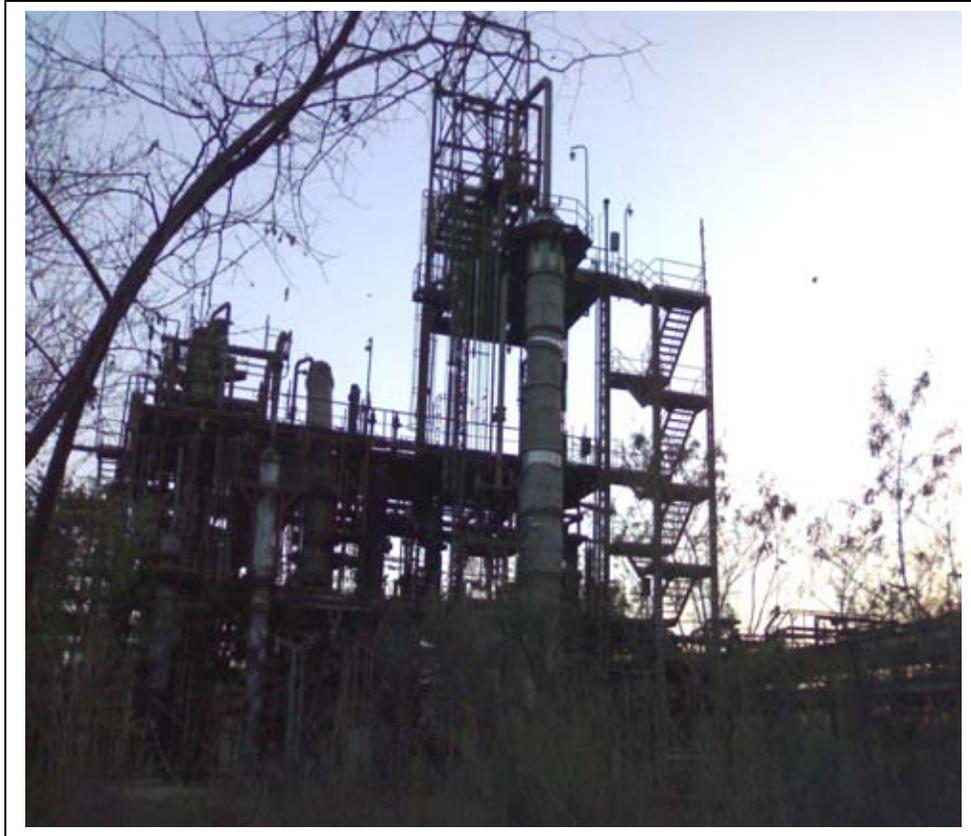
**Plate 1: General view of UCIL plant**

A detailed reconnaissance survey of the UCIL premises and the surrounding area was carried by NGRI and NEERI during the study. During the reconnaissance survey, the NGRI-NEERI teams collected background information on products, processes, raw materials used and the wastes generated/disposed off by UCIL during its operation. Teams also surveyed the existing dumps located within the UCIL premises as well as waste disposal facilities located outside UCIL premises (solar evaporation ponds and secured landfill). **Plate 1** depicts the general view of UCIL Plant.

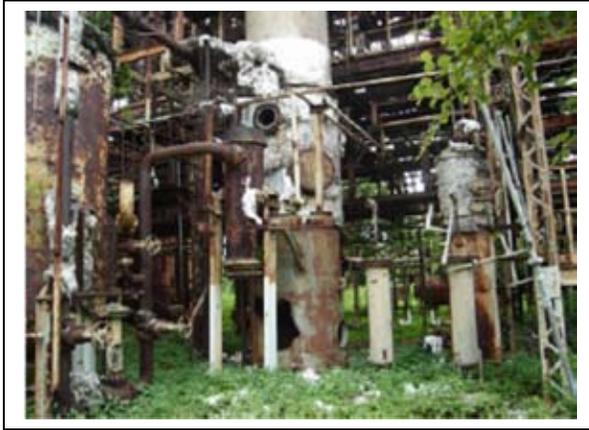
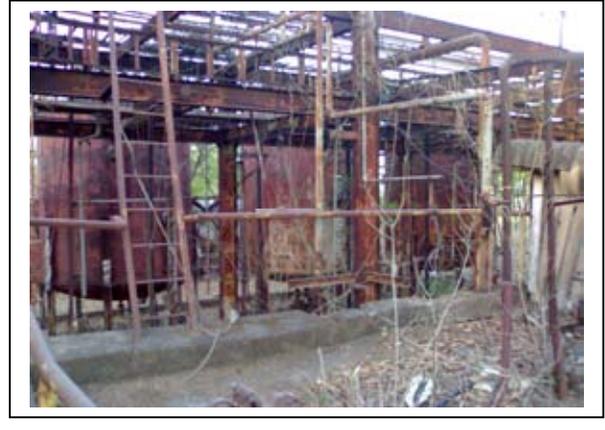
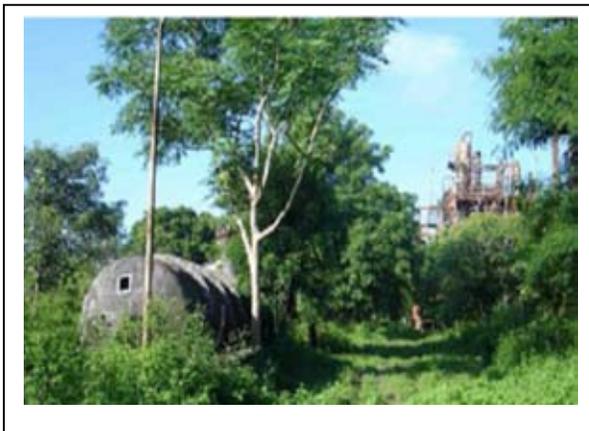
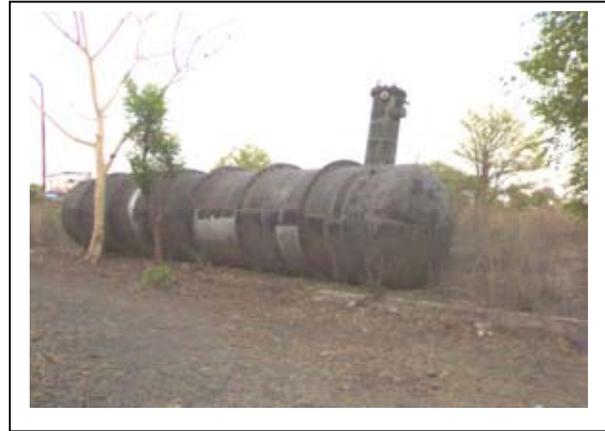
**Plate 2: Plant and machinery in dilapidated conditions**

During the reconnaissance survey of the UCIL premises, the NGRI-NEERI team observed remains of various manufacturing plants, machinery, buildings and sheds within UCIL premises. Most of the plants and machinery was in dilapidated conditions and appeared to be contaminated (**Plate 2**).

- ❖ The reconnaissance survey of the site revealed that most of the plant, machineries and buildings within UCIL premises are in dilapidated conditions and appeared to be contaminated. The reconnaissance survey of the UCIL premises also revealed existence of a number of dumps especially in disposal area I and disposal area II. The existence of dumps within UCIL premises indicated that the excavation and recovery of wastes carried out by Madhya Pradesh Pollution Control Board (MPPCB) through M/s Ramkey Ltd. was incomplete.

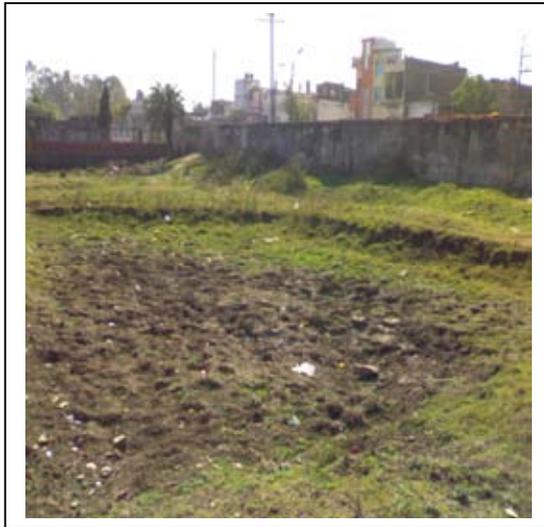
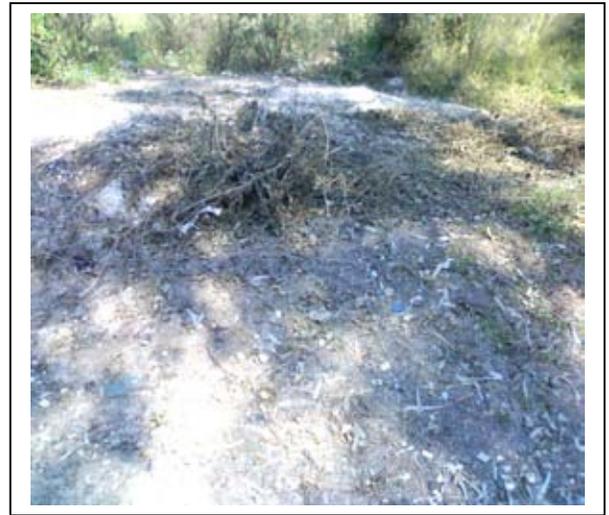
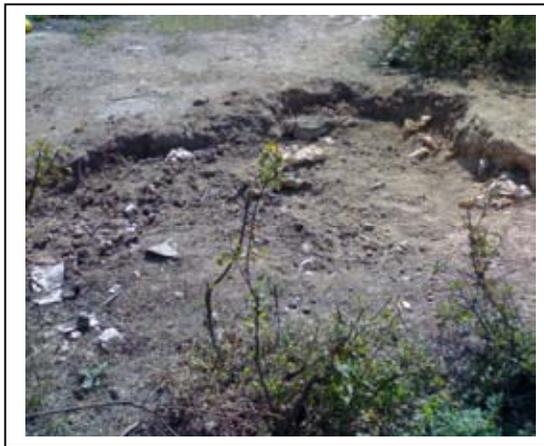
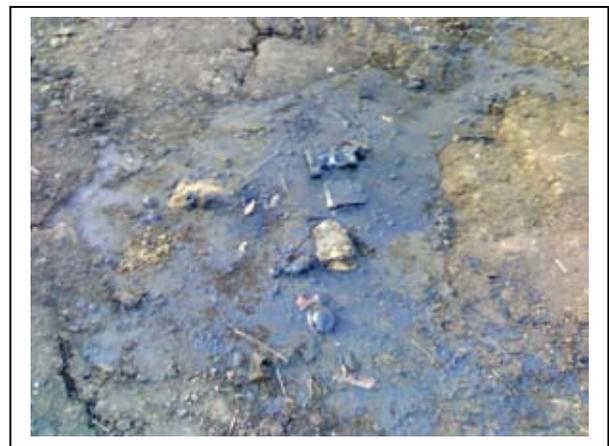
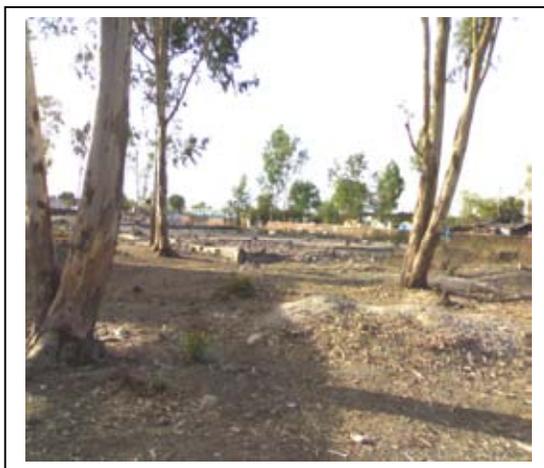
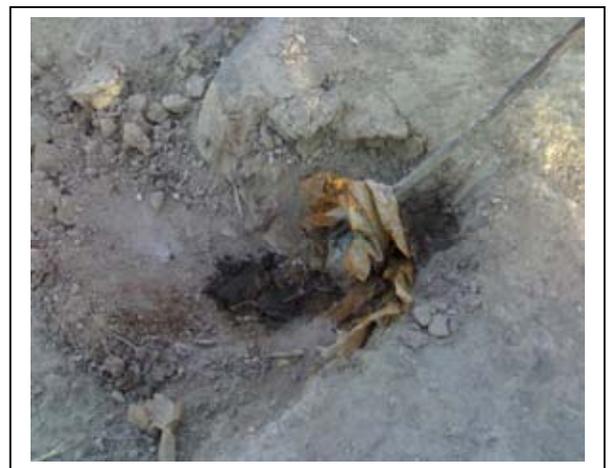
**Plate 3: Existence of dumps within UCIL premises**

The reconnaissance survey of the open areas within plant premises revealed existence of a number of dumps, especially, in disposal area I and disposal area II which give very pungent smell of pesticides. The existence of dumps within UCIL premises indicated that the excavation and recovery of dumped material from the dumpsites, carried out by MPPCB through M/s Ramkey Ltd., is still incomplete (**Plate 3**).

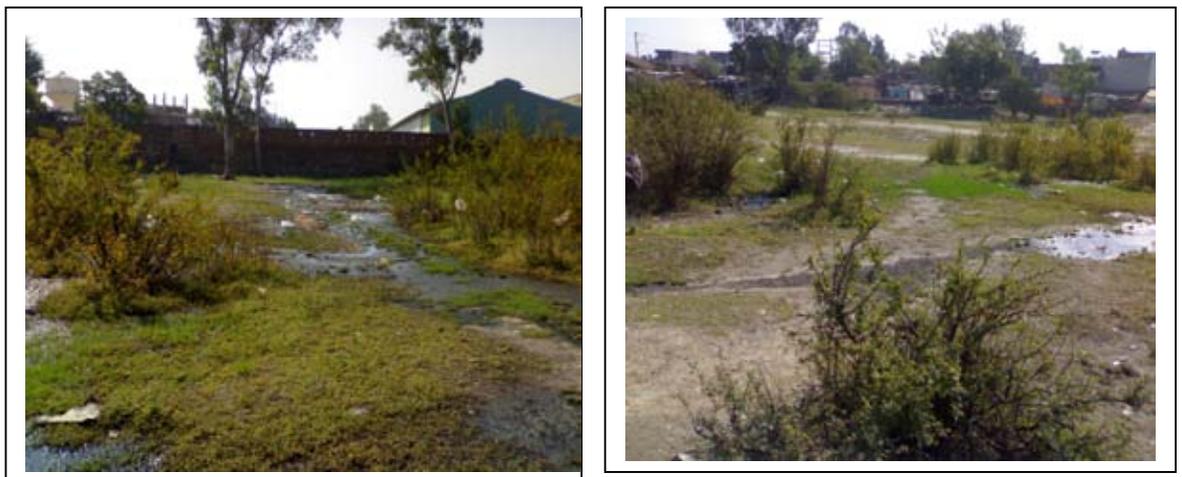
**Plate 4: Wastewater released by the hutments/industries in UCIL**

The boundary wall of the UCIL premises was found to be broken at many places and this provided an easy access to the people living around the premises. Some of the open areas of the premises were also used by children as a play ground. The UCIL premises were surrounded by thickly populated hutments. The wastewater released by hutments and adjacent industries was found to be accumulated at many places within UCIL premises **(Plate 4)**.

- ❖ The boundary wall of the UCIL premises was found to be broken at many places which provided an easy access to the people living around the premises.

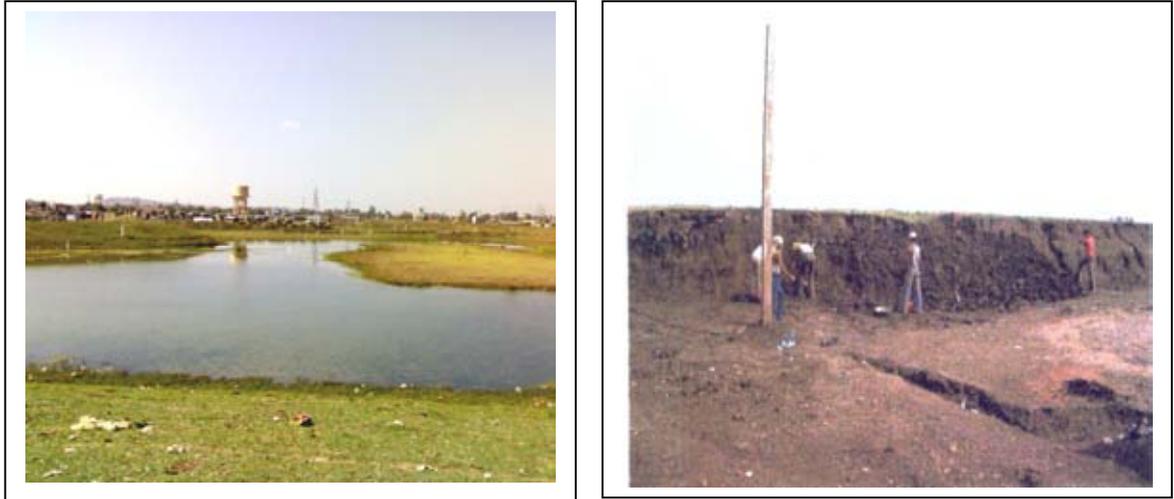
**Plate 5: Improper management of SEP and abandoned landfill**

The reconnaissance survey of the SEP area outside the UCIL premises revealed existence of one SEP which was partially filled with water. The SEP was un-guarded and was found to be littered with night soil and other domestic refuse **(Plate 5)**.

During the reconnaissance survey, it was learnt that out of three SEPs, two were converted into a secured landfill for the disposal of dried sediments from SEPs. The high density polyethylene liners from SEP and secured landfill were found to be damaged/removed during the reconnaissance survey.

- ❖ The reconnaissance survey of the SEP area outside the UCIL premises revealed existence of one SEP and an abandoned landfill which were found to be damaged.

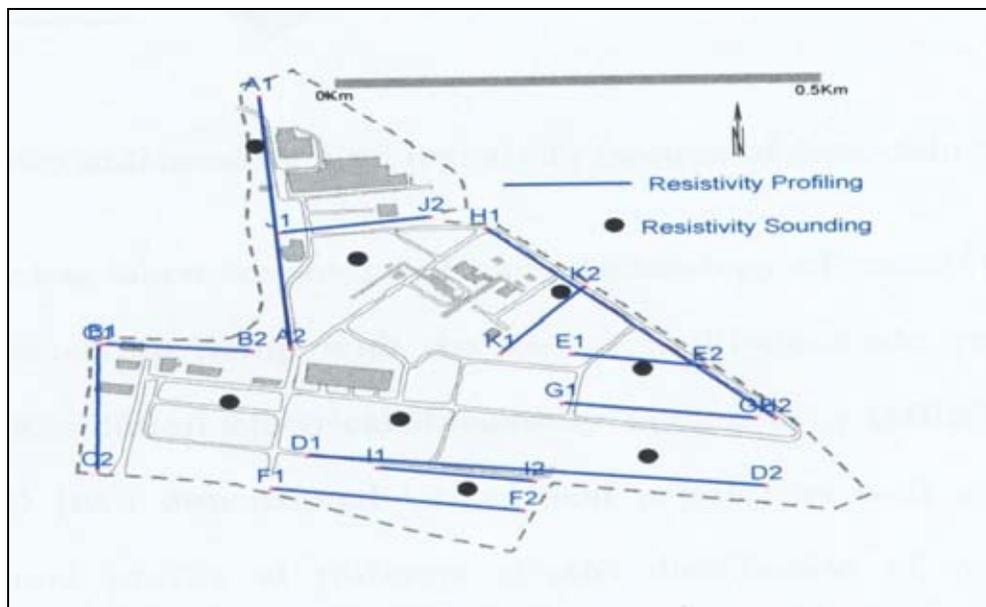
**Fig. 3: Electrical Resistivity Profiling (ERP)**

The geophysical investigations were carried out by NGRI in 1994 within UCIL premises for delineating subsurface formations (using resistivity sounding) as well as identifying possible dump areas (using resistivity profiling). The VES revealed a predominant subsurface formation of black cotton soil followed by silty soil, soft fractured sand stone and hard sandstone as bedrock. The combined thickness of black cotton soil and silty soil was inferred to be 15.3 to 58.9 m. The depth of hard sandstone was inferred to be 16.9 to 69.6 m below grand level. The ERP carried out at 11 traverses covering entire UCIL premises (**Fig. 3**) revealed that 5 traverses (D, E, G, H, and I) were laid over possible dump materials. The soil samples collected in these areas had confirmed existence of contaminants such as temik or sevin.

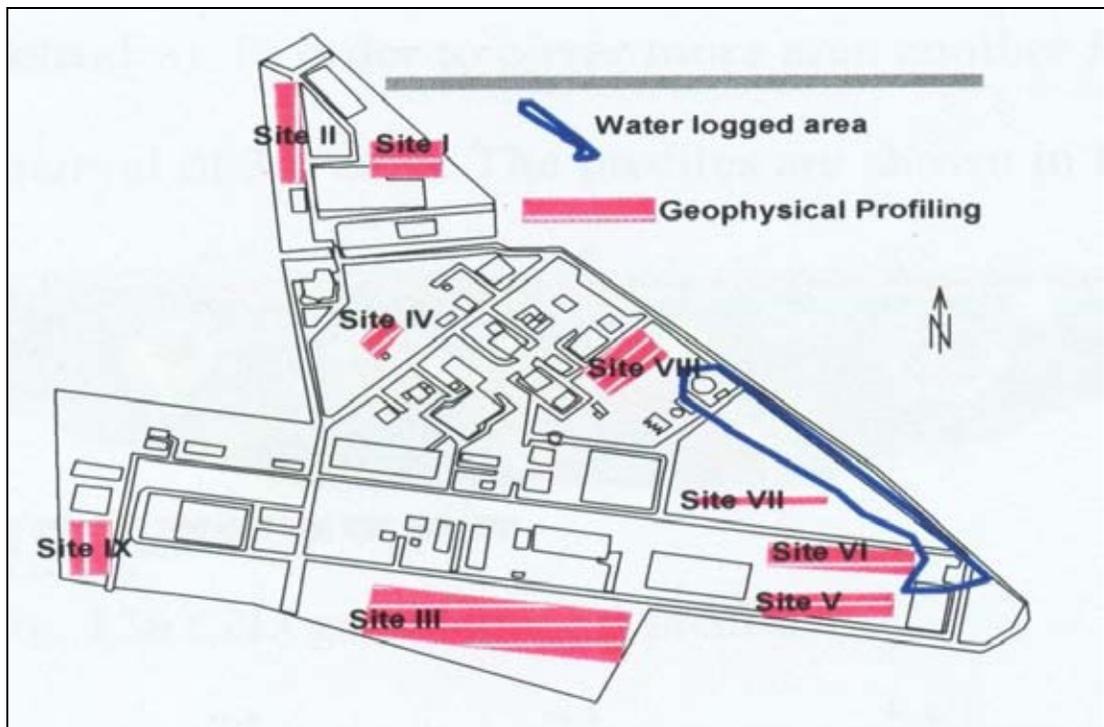
**Fig. 4: Locations of HERT survey**

The HERT was carried out across the selected areas based on background information about the site as well as physical limitations at site (existence of concrete structures, sheds, bushes, water logging, roads etc). A total of nine sites within the UCIL premises were covered during the HERT survey. The locations of HERT survey are depicted in **Fig. 4**.

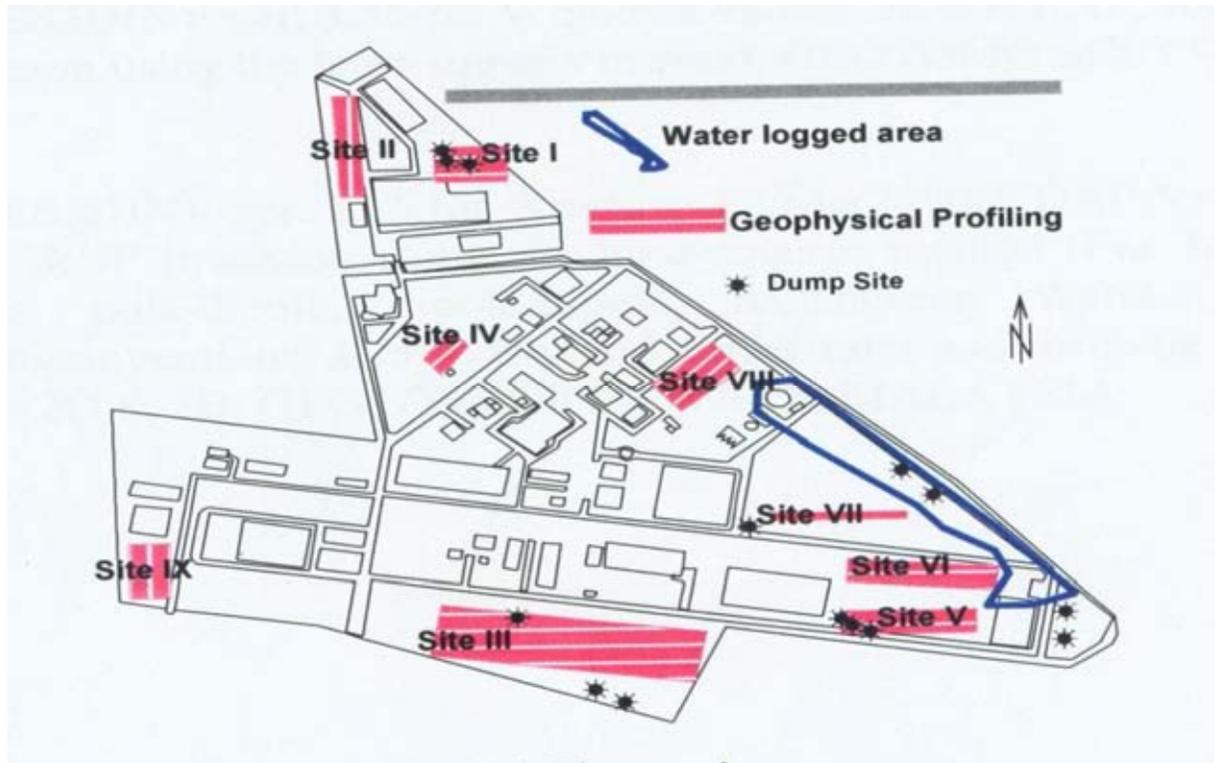
**Figure 5: Locations of suspected dumps at UCIL premises**

**Site I :** The site is situated in the northern part of the premises in front of Formulation plant (**Fig. 5**). The heaps of dumps were visible at the open space emitting pungent smell of pesticides. The HERT profiles were laid across the dump in EW direction. at an electrode separation of 1m so that the dumps are adequately covered.. A total area of 9m x 48m was covered at this site. It was observed that the dumps showed higher resistivity of the order of 100 to 300 ohm-m as compared to the resistivity of about 5 to 8 ohm-m for black cotton soil. The dumps were clearly demarcated in the profile with depth from few cms to about 1m.

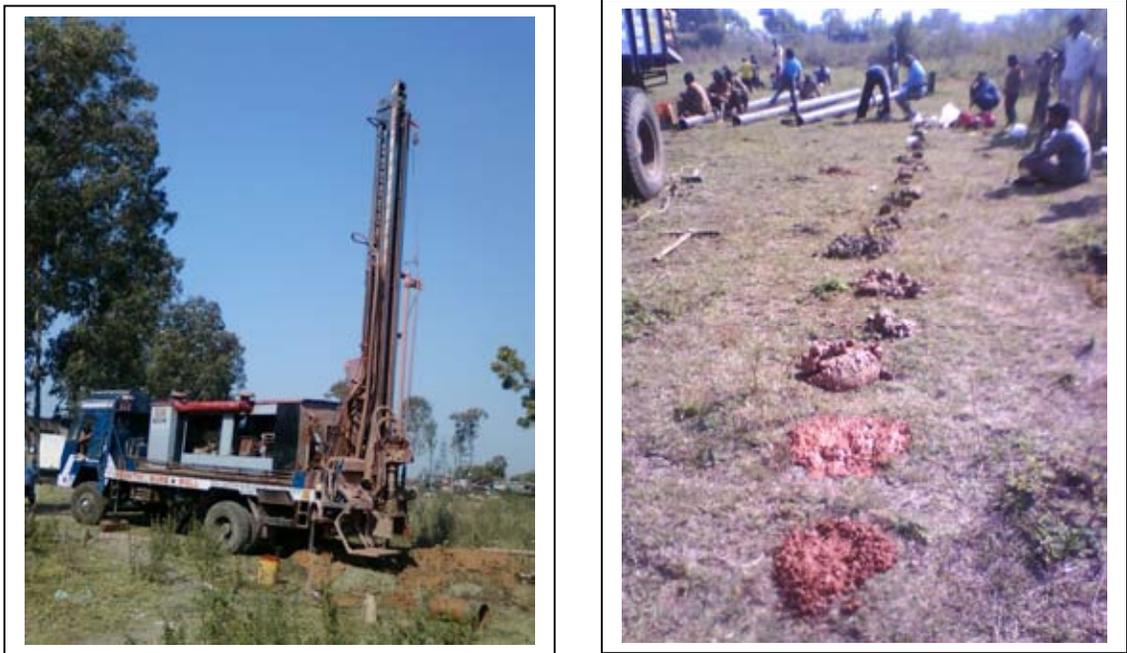
Plate 6: Drilling of borewells within UCIL premises

Based on the data generated during drilling of test borewells it was observed that the weathered basalt is overlain by black silty clay of 10 to 17 m below ground surface. The basalt is further overlain by yellow silty clay and its depth varies from 22 to 25 m. The underneath formation is sandy alluvium with pebbles which is saturated with water forming aquifer. The thickness of this aquifer varies from 0.7 to 4.6m being thickest in eastern part of UCIL premises. Water was struck at about 25 m below ground surface and risen to about 8.5 to 14 m indicating that aquifer may be in confined condition. The entire bore wells were screened only in the lower part against aquifer and remaining portion is sealed with iron casing so as to prevent cross contamination of aquifer.

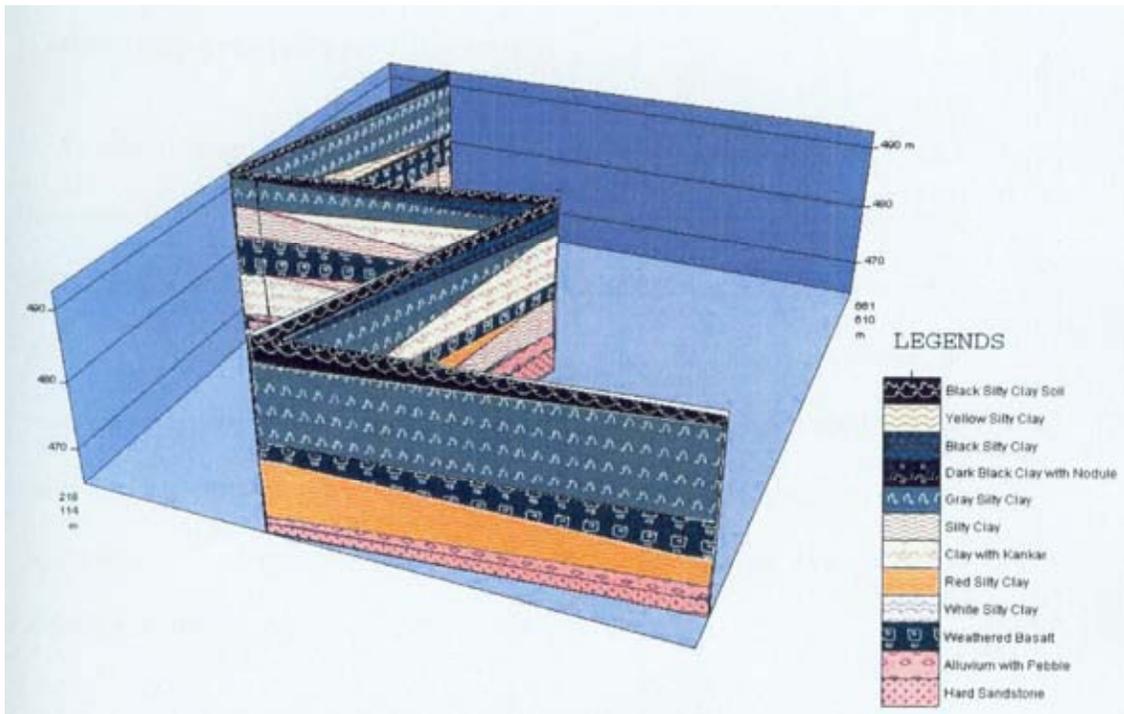
Figure 12: Fence diagram showing geological strata at UCIL premises

It may be concluded from the hydrogeological studies that entire area of UCIL premises is occupied by a thick layer of black silty clay and yellow silty clay upto a depth of about 22 to 25 m below ground level. The groundwater occurs in sandy alluvium with pebbles at a depth of around 25m below ground surface under confined condition. The groundwater flow direction in and around the UCIL premises was in south-east direction which could change with time. It was also reported by NGRI that there existed a subsurface elevation or mound near the central part of the UCIL premises, which diverted the subsurface water flow in north-east or south-east directions depending on the approach of the flow.

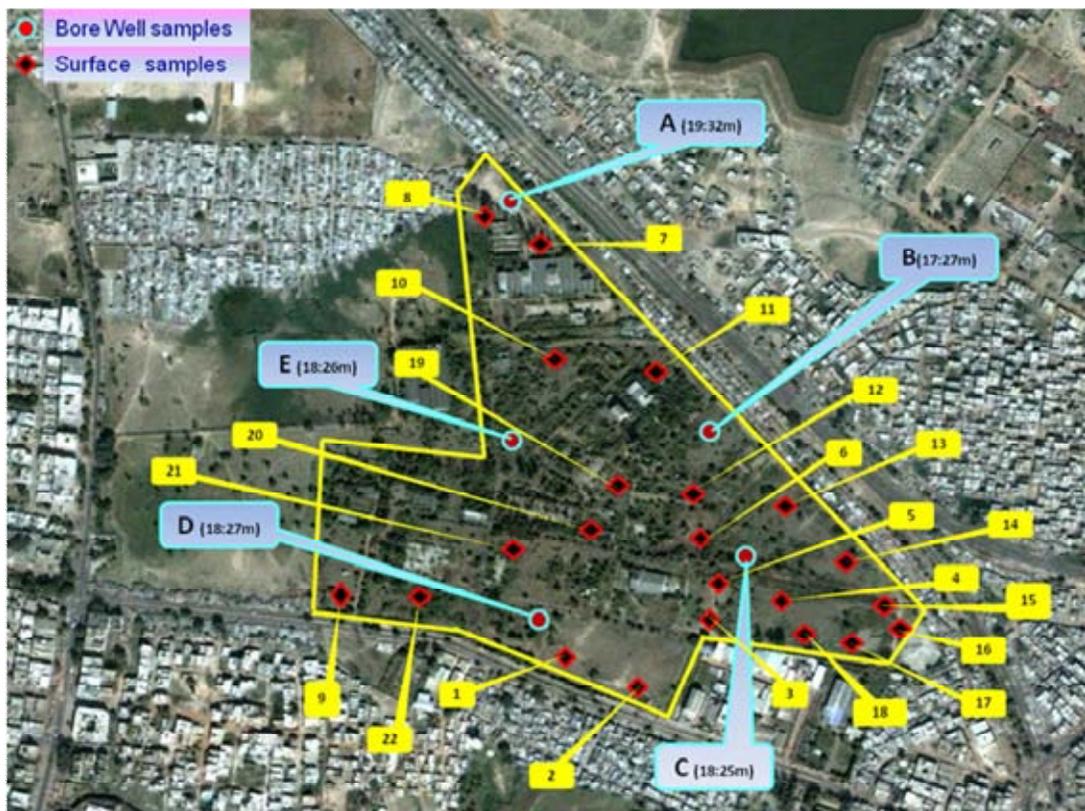
**Figure 13: Locations of soil samples collected within UCIL plant premises**

The boreholes were drilled by NGRI adjacent to the suspected contaminated areas so as to prevent cross contamination of aquifer. Hence, additional 27 surface and subsurface (30 cm deep) soil samples were also collected from the exact locations of the suspected contaminated hot spots within UCIL premises (**Figure 13, Table 8**).

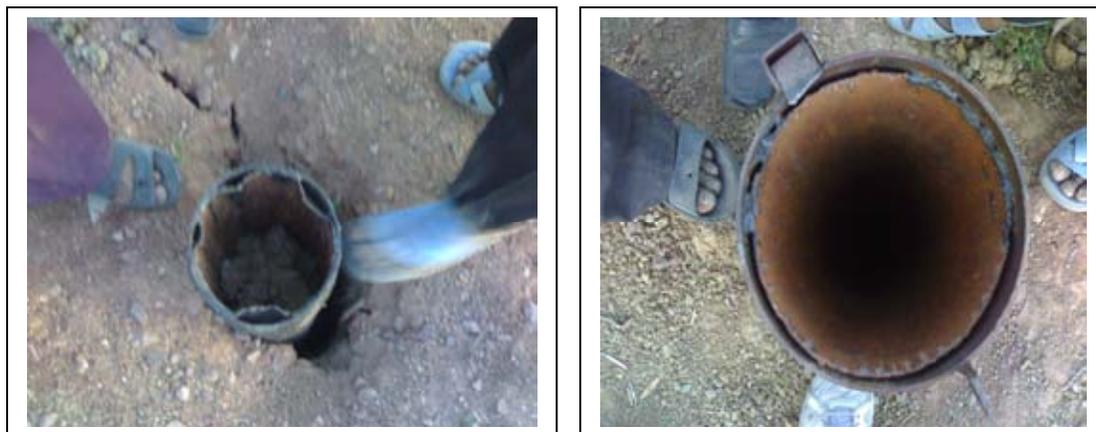
**Plate 7: Tampered/broken borewells within UCIL premises**

**The confirmatory sampling of these borewells was attempted by NEERI in May 2010. However, during the visit, all the borewells constructed by NGRI were found to be broken, tampered and filled with unknown materials. Hence, repeat sampling could not be done for these borewells.**

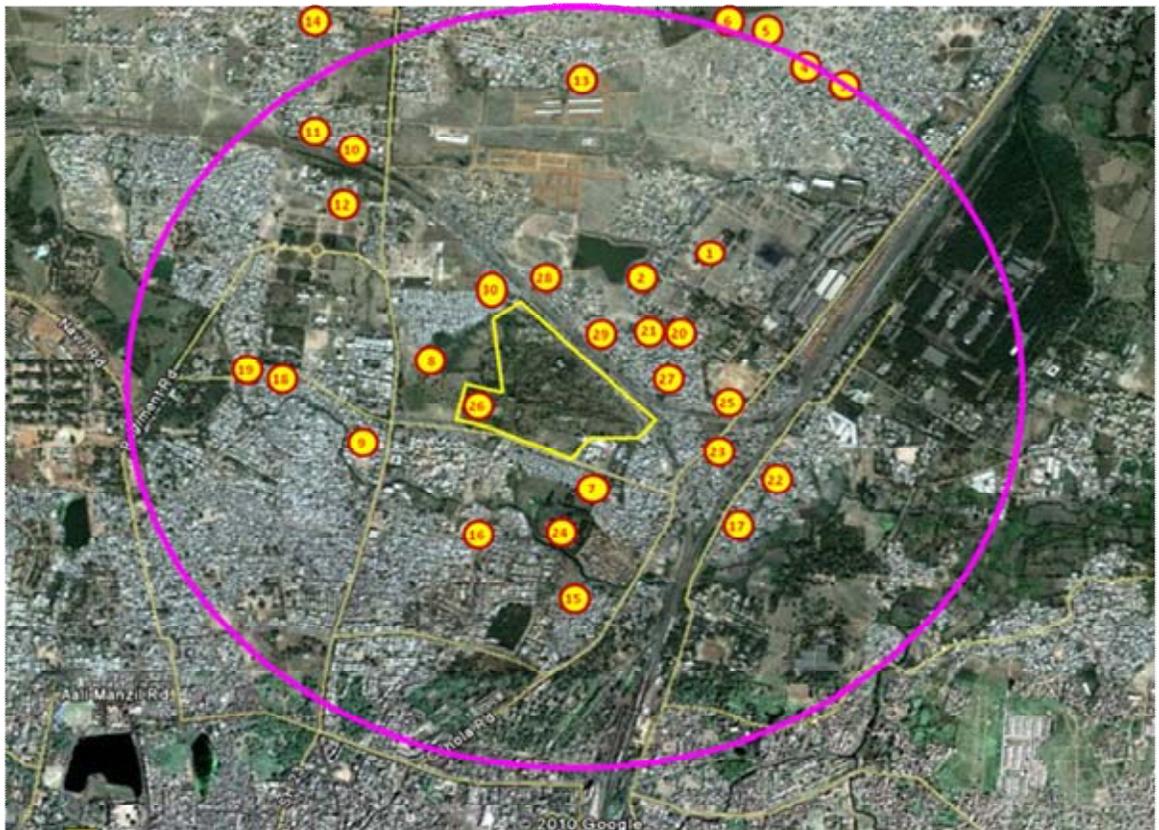
**Figure 15: Locations of groundwater samples collected around UCIL premises**

In addition to the above mentioned groundwater samples, samples were also collected from the existing sources (dug wells, bore wells and hand pumps) around the UCIL premises. The groundwater sampling was done considering the groundwater flow direction, which is in general towards North-East. The locations and details of groundwater samples collected around the UCIL plant are presented in **Figure 15** and **Table 10**. The samples were preserved and transported as mentioned in the previous section.

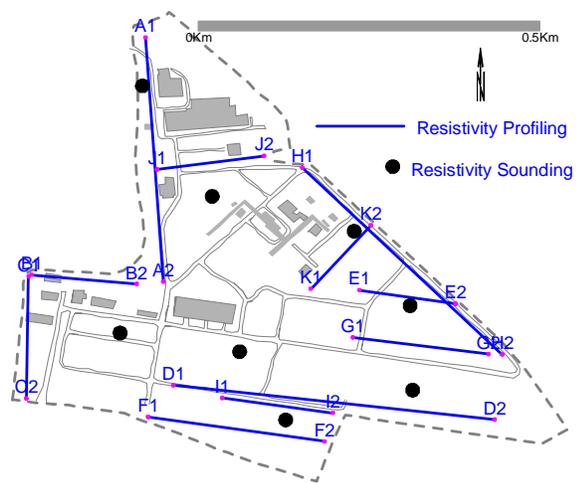
Fig. 4: Resistivity profiling & soundings during 1994

out using Wenner array with 2, 5 and 10m electrode separations. The details of the profilings are described by Jain et al (1994). Based on the variations in the resistivities the probable dump sites are concluded as shown in Fig.5a. The top layer resistivity data also indicated higher resistivity in the southern part, north and northeastern parts as that could be location of dumps (Fig. 5b). A low resistivity between Storage Tanks and Neutralization Tanks indicated degradation of soil.

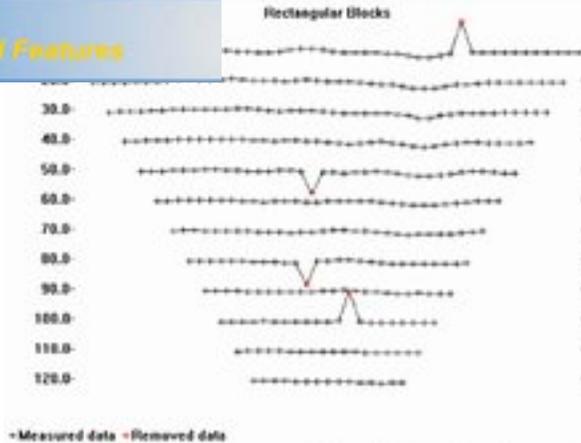
Fig. 8: Example of data set with few bad points (source: RES2DINV Manual)

The entire downloaded data were first checked for errors. Any error in the measured data was removed while processing through RES2DINV. An example of bad data record is shown in Fig. 8 . Such bad data records are removed before interpreting the profile.

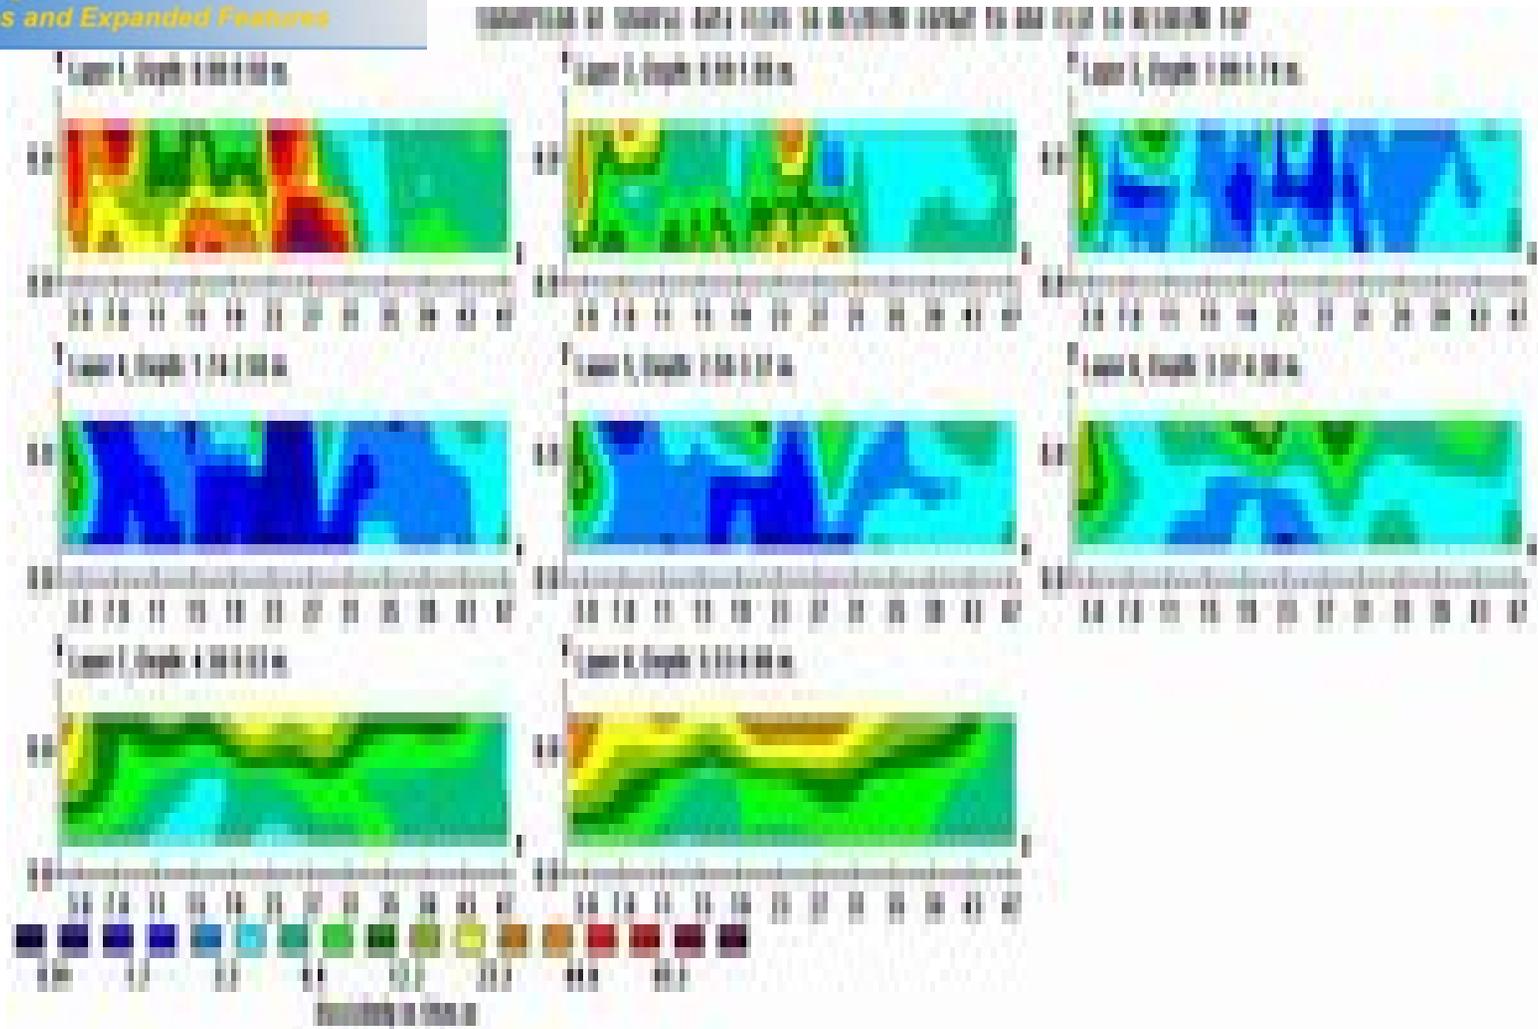
Fig. 14 : 3D geo-electrical profile at different depths

It can be seen that as we move northward the depth of eastern dumps decreases whereas the depth of western dump increases. Therefore an area of 9mx48m has been covered. Since there are demolished structures, we could not cover further area in this part of premises. The 2D data were used to infer 3D profile using software RES3DINV and the distribution of resistivity at different depths is shown in Fig. 14 . It can be easily seen that the dumps and their depths are clearly indicated. Further, it can be observed that the soil below the dumps have low resistivity of about 1 ohm.m. Could it be affected by leaching of dumps?

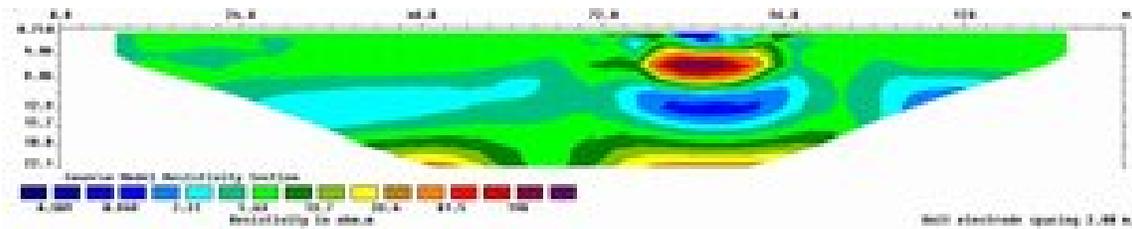
Fig. 17: 2D geo-electrical profile

However these are known dump sites. Although there is no sign of any dump heap, we covered entire open area by selecting electrode separation of 3m in EW direction with 1<sup>st</sup> electrode in the area that is opposite Police post. The site is selected in the open area which is in the southern part of premises and south of road opposite to Storage tank or near Neutralization pit (Fig. 11). The western part of the area is occupied by metal road and demolished structures hence that part is not covered. The obtained data is interpreted as described above and the profile is shown in Fig. 17.

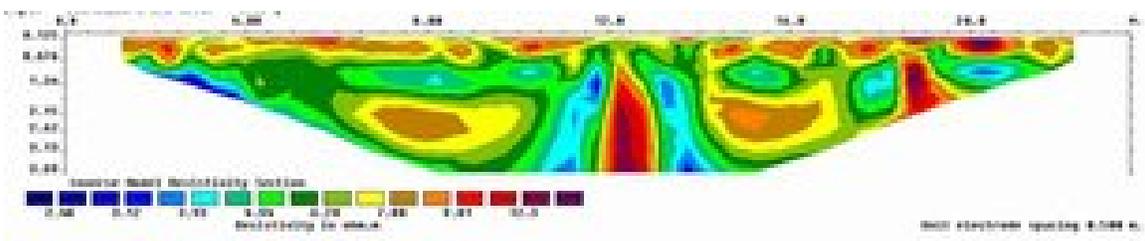
Fig. 21a: 2D geo-electrical Profile

in the open space close to tower (Fig. 11). Due to limitation of space we restricted electrode spacing to 0.5m with total profile length as 23.5m in NS direction. The spacing between another two profiles was kept as 2m each. The obtained data was edited for error and interpreted using RES2DINV software. The final profile obtained after several iterations is shown in Fig. 21a, b and c.

A low resistivity profile indicates clay and no dump were inferred from this profile. However in the middle of profile slightly high resistivity is recorded and it is due to pot hole created in the ground along the cracks in the clayey soil. A 3D profile at various depth is shown in Fig. 22.

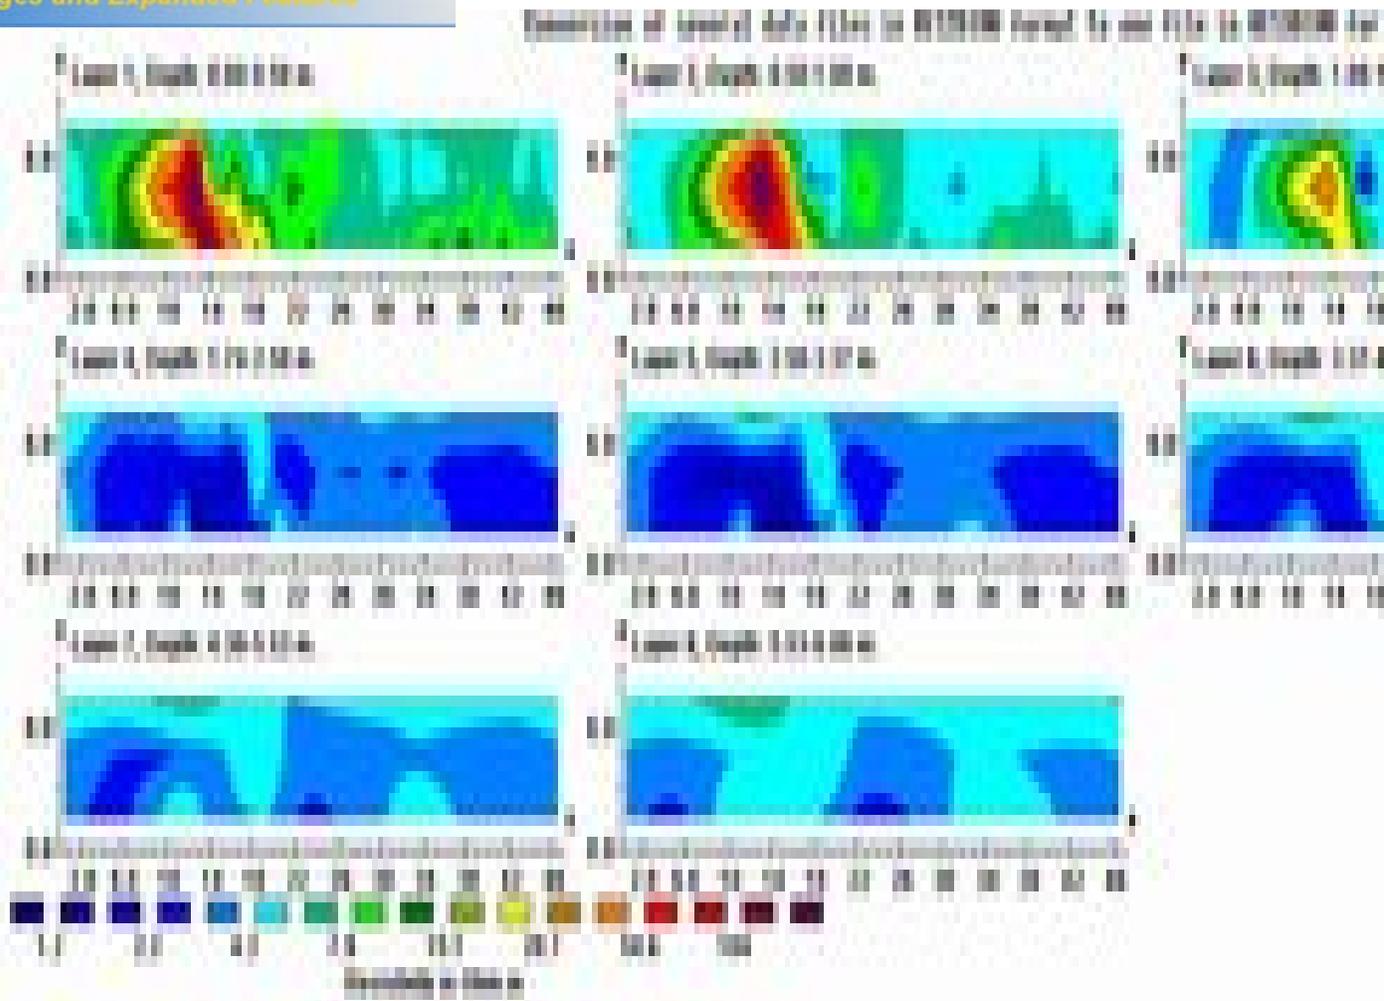
Fig. 25: 3D profile at various depth at site V

is generated using all the 2D data and the inferred 3D profile at various depths is shown in Fig. 25.

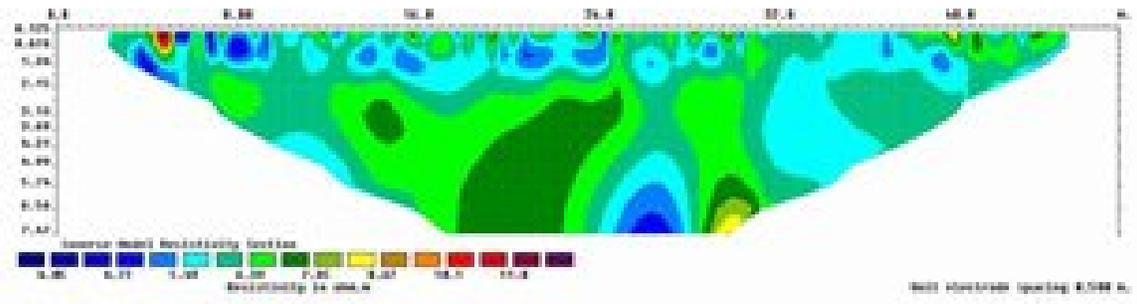
Fig. 30: 2D geo-electrical profile

**Site VIII :** The site is selected in the close vicinity of the plant in the eastern direction. Part of this area was also water logged and some are covered with bushes. The profile was taken in N70<sup>0</sup>E as shown in Fig. 11. A 2D profile was taken and the processed data was interpreted for resistivity profile which is shown in Fig. 30.

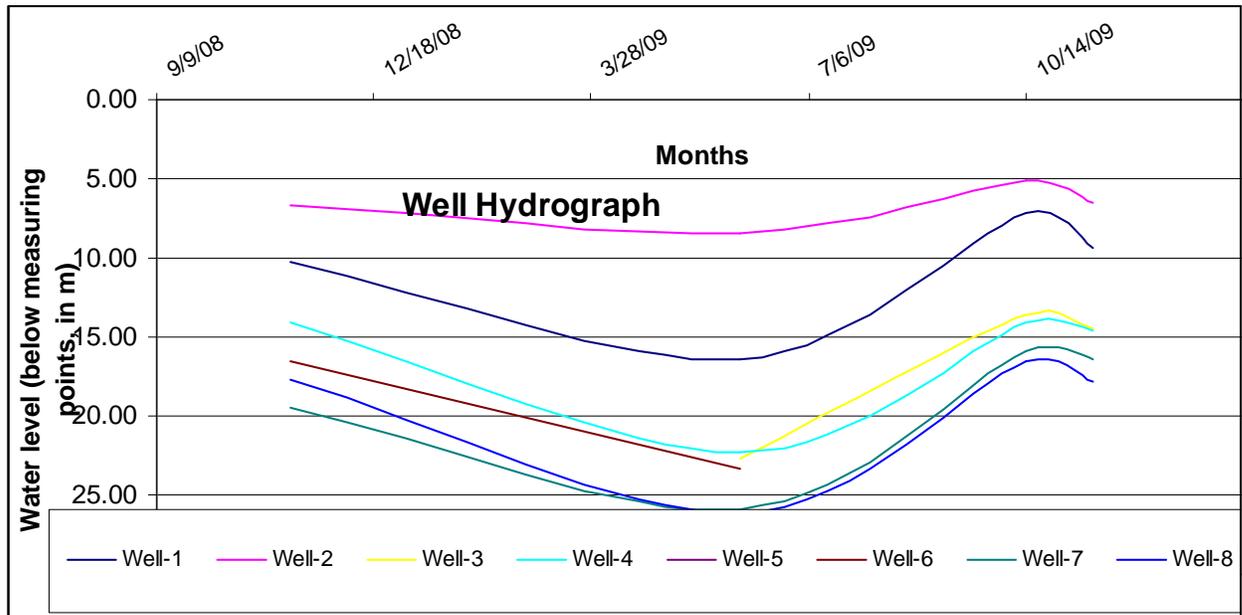
Fig. 7 Well Hydrograph of wells at the periphery of area

The well hydrograph is shown in Fig. 7 depicting variation in the water level. It can be observed that water level variation ranges from 3.4m to 23.37m due to monsoon of 2008-09.

The lowest variation of 3.4m is observed in the shallow dug well outside the area and it may be a localized shallow aquifer. The remaining all the bore wells have shown similar behavior with a variation of about 9-10m, except for a well in the eastern part (23.37m) which has very high abstraction ( almost running for 24hrs).

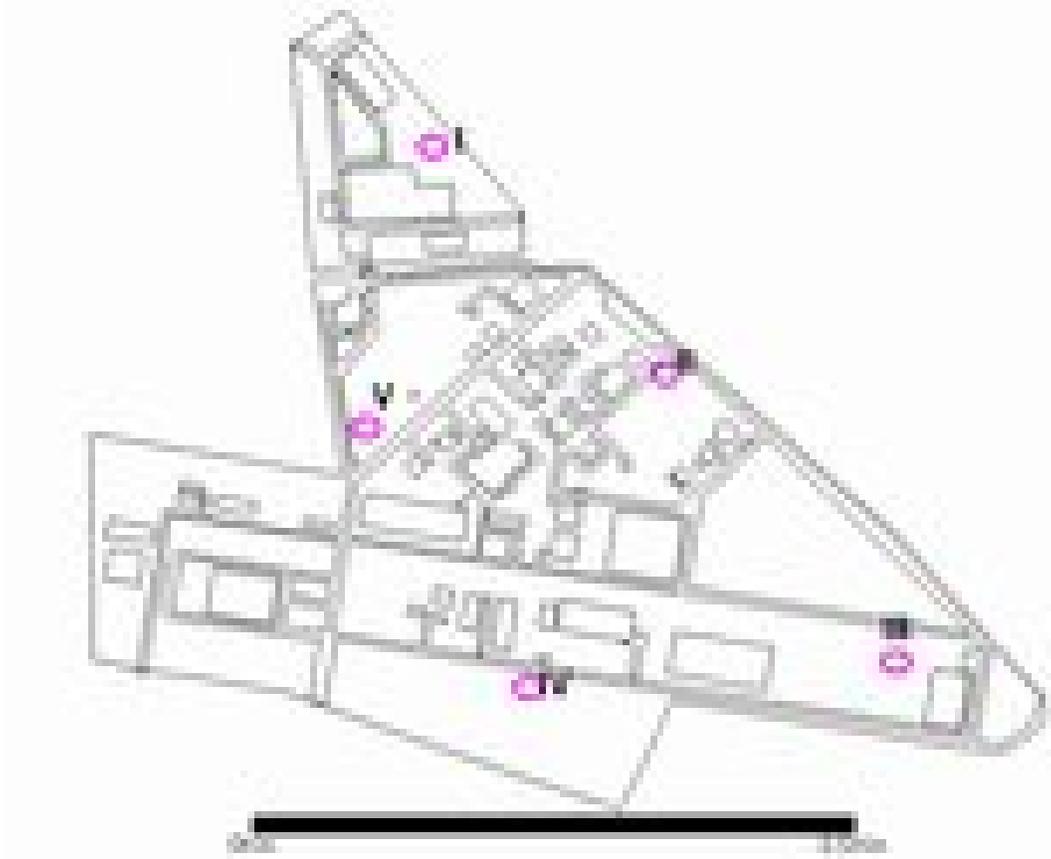
Fig. 8 Location of Drilling sites

As there were no wells in the vicinity of plant, neither any lithological information was available; five sites were selected to carry out drilling for exploration of aquifer zone in the area. The selected sites for drilling are shown in Fig. 8. Lithologs were collected at different intervals during drilling. The lithological description of each site is given below.

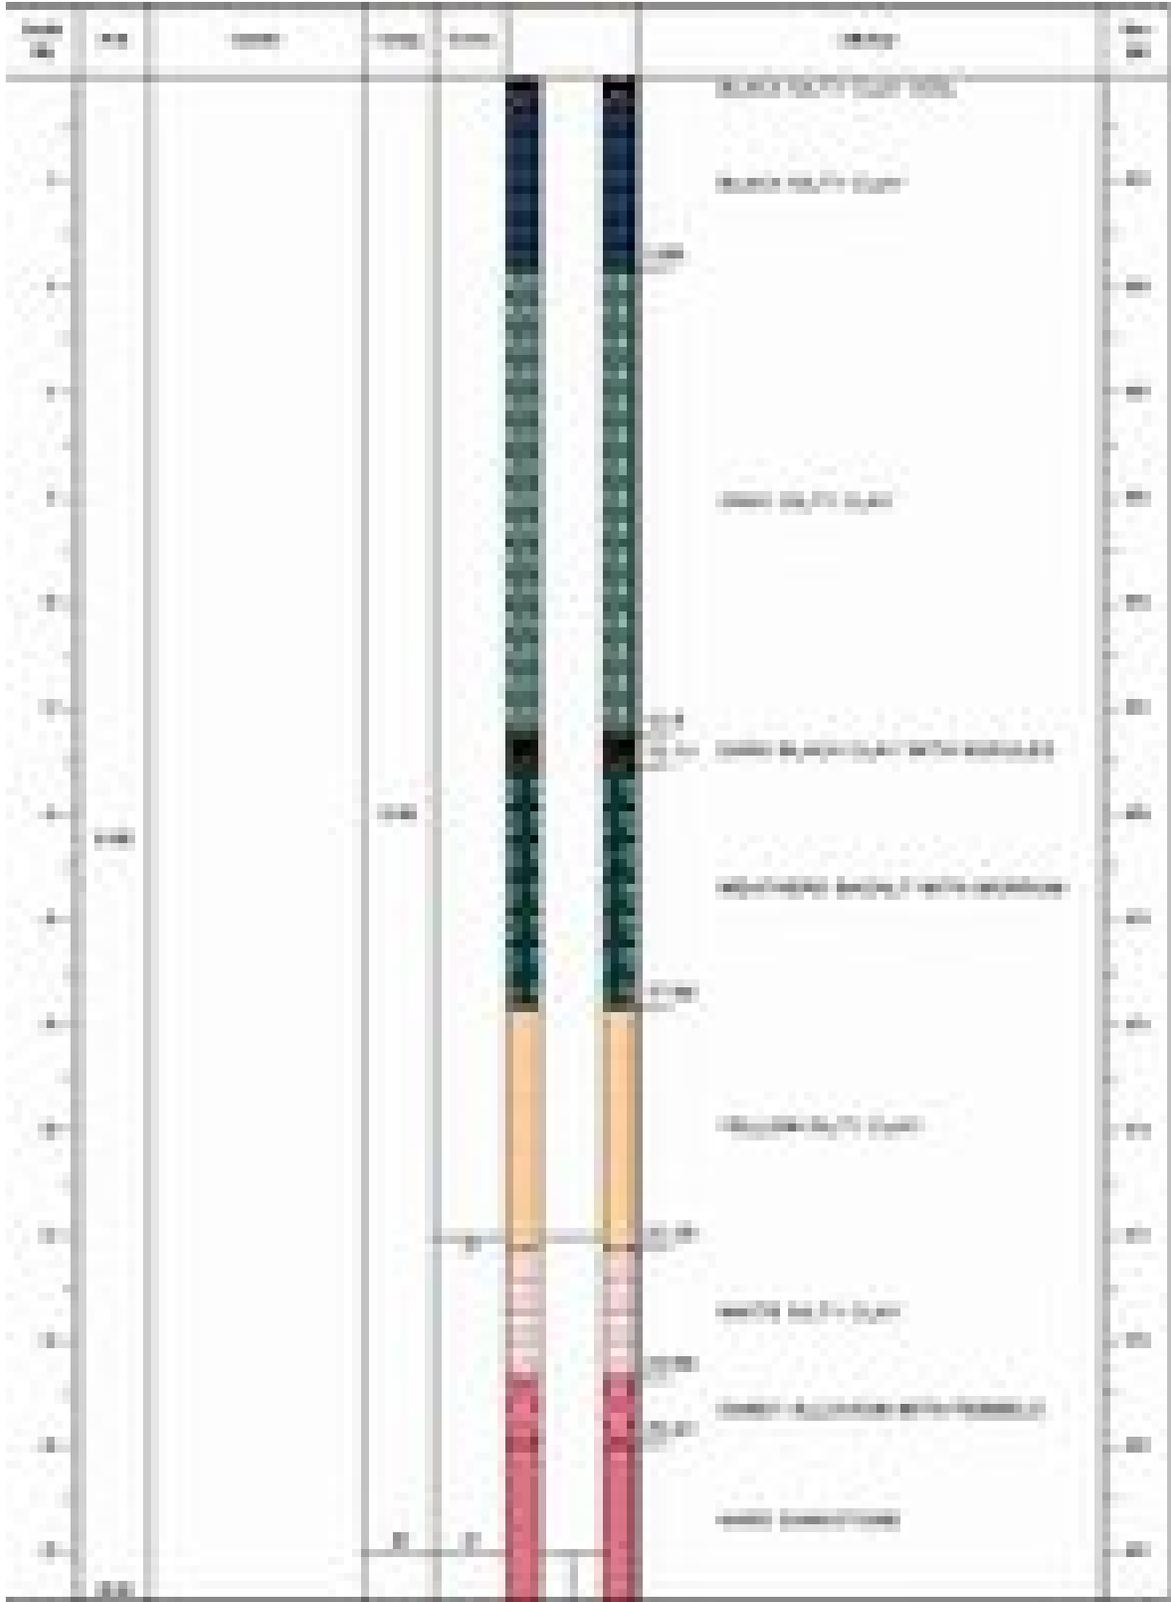
Fig. 9 : Litholog and drill time log.

**Site I** : Drilling has been carried out in the northern part of the area in the front of formulation plant as shown in Fig. 8. The drill litholog is shown in Fig. 9.
