**Final Report**

**Assessment and Remediation of Hazardous Waste  
Contaminated Areas in and around M/s Union  
Carbide India Ltd., Bhopal**

**Bhopal Gas Tragedy Relief and Rehabilitation Department  
Govt. of Madhya Pradesh, Bhopal**

**National Environmental Engineering Research Institute  
Nehru Marg, Nagpur - 440020  
([www.neeri.res.in](http://www.neeri.res.in))**

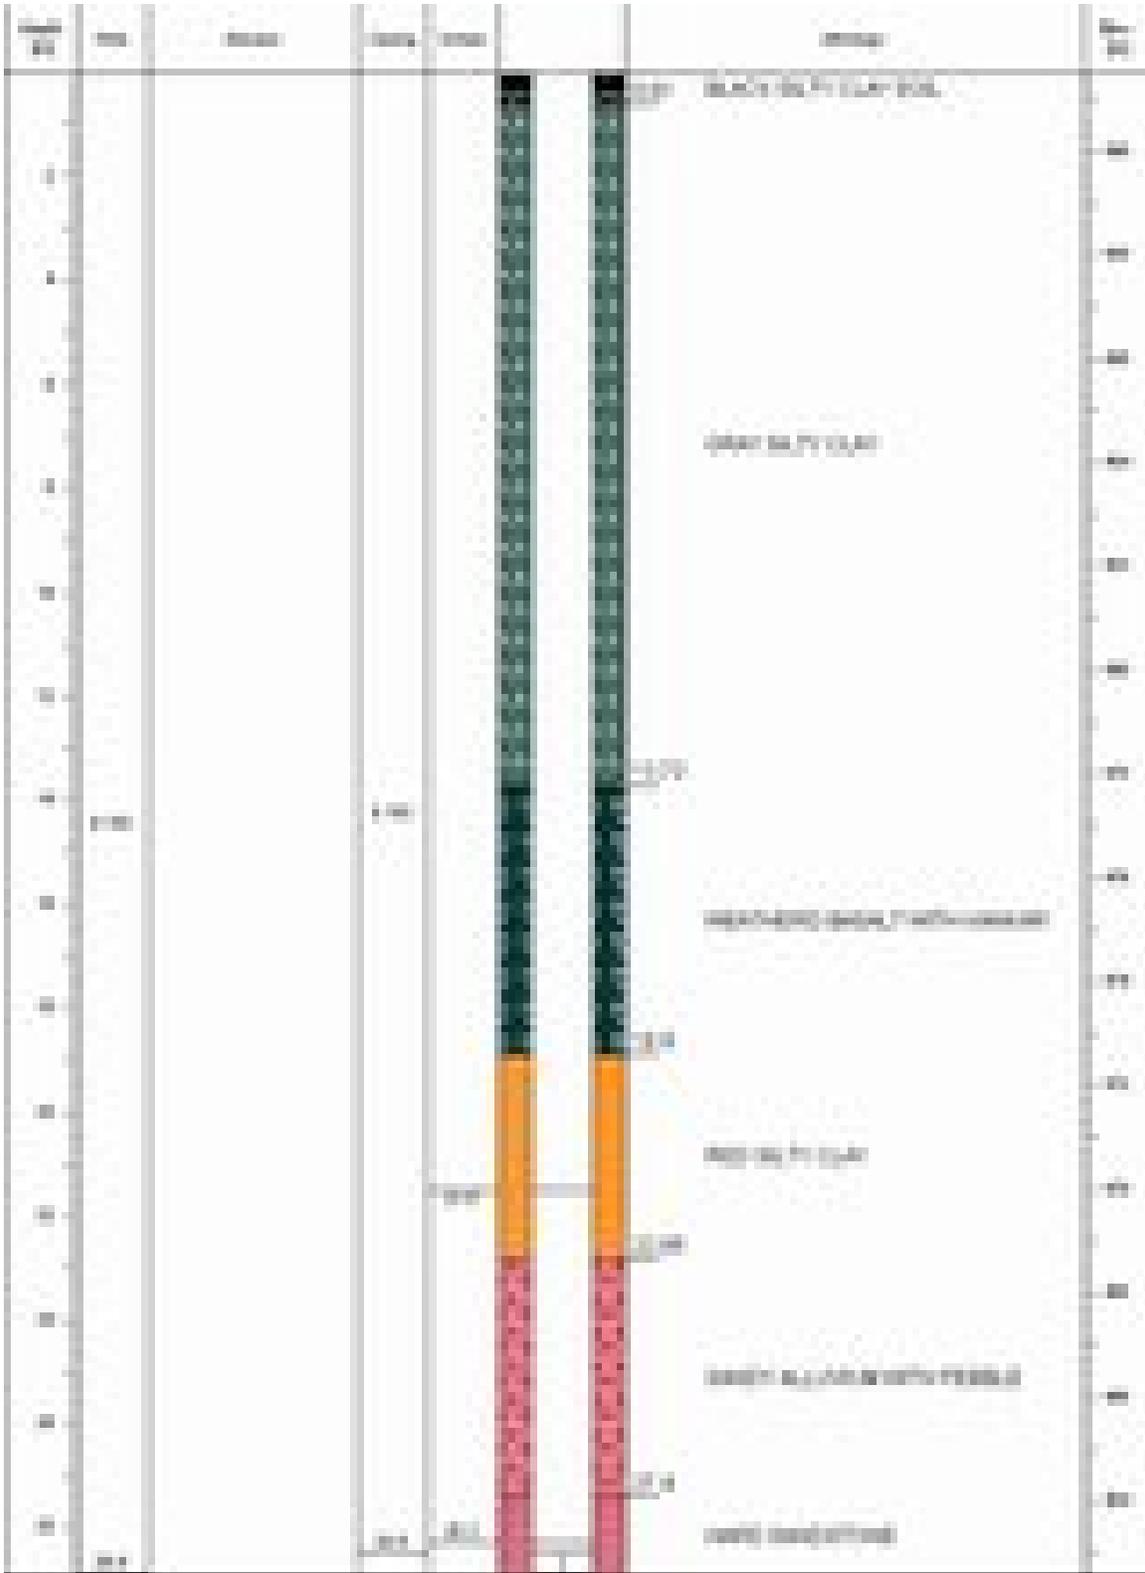
Fig. 11 Litholog and drill-time log at site III

**Site III :** The site was selected in the southeastern part of the area, near solar evaporation pond as shown in Fig. 8. The litholog obtained during drilling is shown in Fig. 11. The top layer of gray silty clay is overlain by black cotton soil. The weathered basalt of about 5.2m is followed by again silty clay up to the depth of 23m. The alluvium with pebbles is encountered with a thickness of 4.6m which is underlain by hard sandstone and drilling was terminated thereafter. The water was stuck at 22.85m. The water level measured after 24hr was 8.5m bgl.

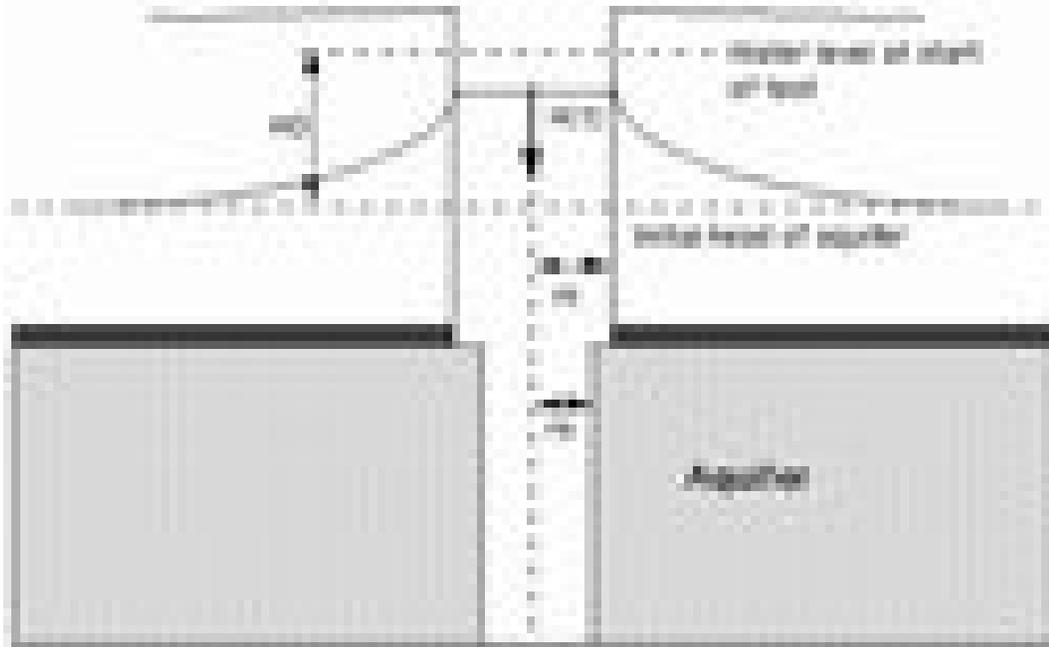
Fig.16 Slug Test (after Cooper et al 1967)

Slug tests were conducted at all the drilled bore wells. These data were used for deriving aquifer transmissivity using method described by Cooper et al (1967) and using software AquiferTest Pro (2007).
