RESTORING LAKES IN URBAN AREAS THROUGH POLLUTION ABATEMENT

Authors: Sushmita Sengupta, Swati Bhatia and Pradeep Kumar Mishra

INTRODUCTION

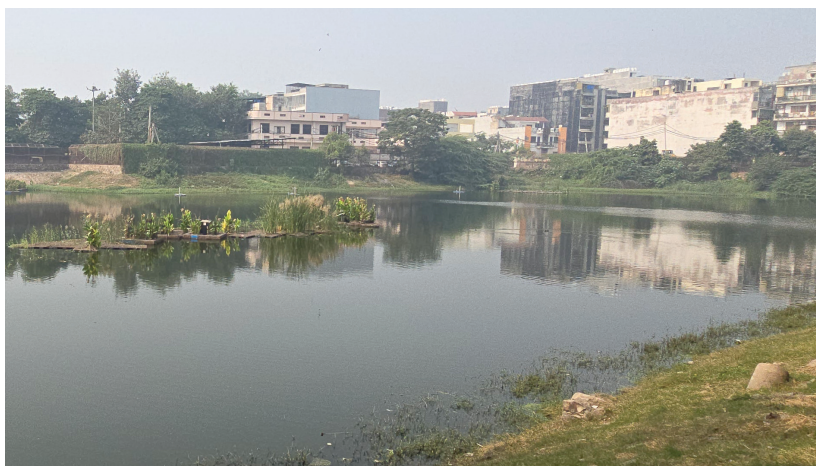
Floating islands within Hauz-i-Shamsi help clean the lake.

Installation of a constructed wetland system (CWS) and floating bio islands were the two major initiatives that addressed the issues; these interventions were in line with the Delhi Jal Board's guidelines. The CWS used natural wetland functions to treat water contaminants, significantly reducing BOD, COD, nitrogen, phosphorus and suspended solids. Floating bio islands addressed waterborne pollutants by mimicking natural floating islands to reduce suspended solids and organic carbon.

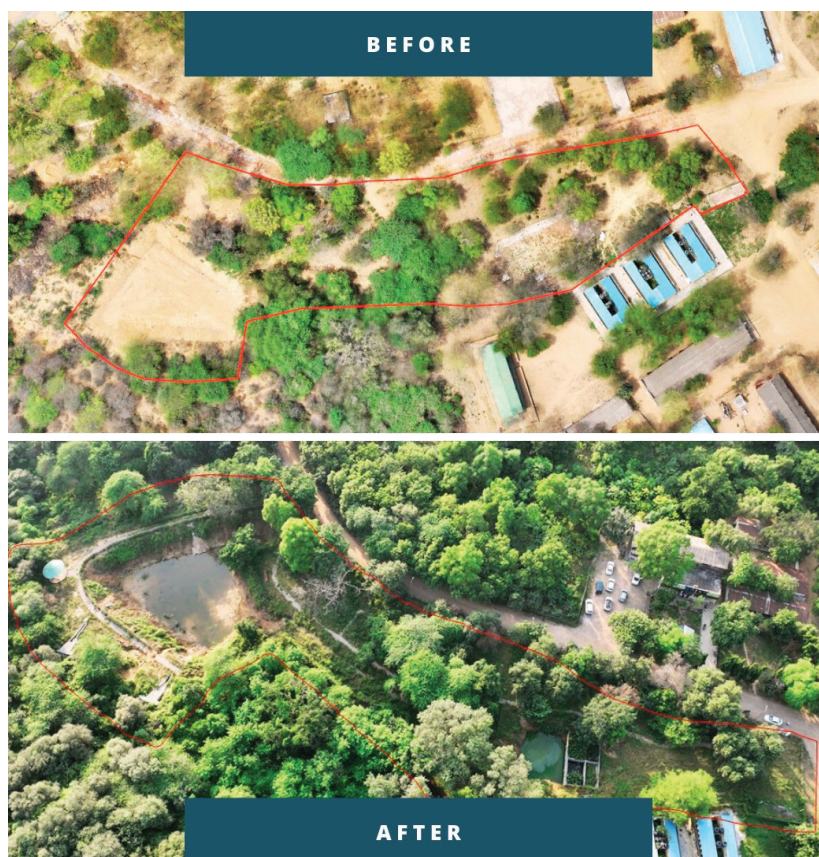
Shaheed Ahlawat pond pre- and post-restoration

The existing septic tank connected to the public toilets was converted to a biodigester, which was then connected to a root zone treatment system, a polishing pond, and then to a spillover pond to oxygenate the water and facilitate the UV treatment. The pond was at a specific distance from the treatment unit, so to channelize the water to the pond, a bioswale—a shallow trench with gravel and nutrient-absorbing plant species through which water flows, thus ensuring further removal of residual nutrient and pathogens that remained after treatment—was created. The treated water then recharges the pond. The treatment plant could treat 75 KLD of wastewater per day.

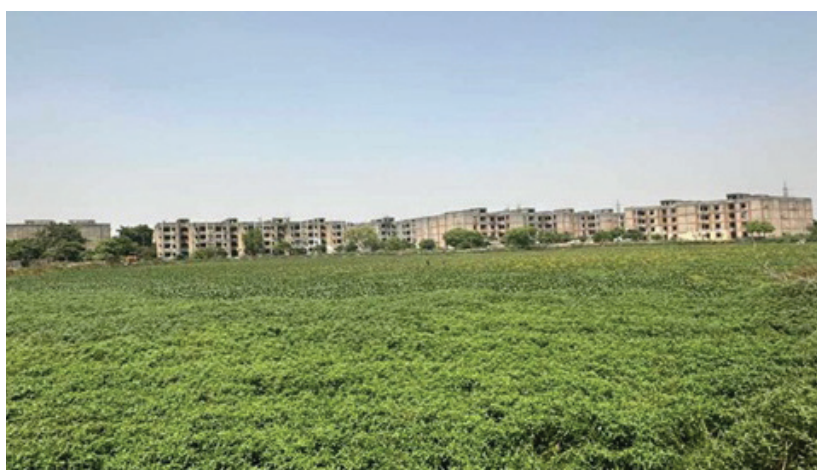
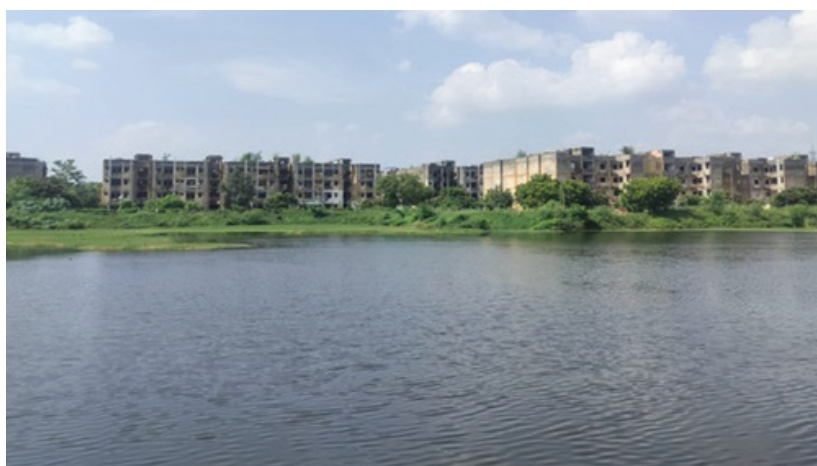
Sadarpur tank pond pre- and post-restoration

The pond was dewatered, desilted, desludged and fenced to secure the site. A nature-based gravity-driven treatment system was opted for, which included treatment of wastewater anaerobically. This involved passing the water through a planted gravel bed for oxygenation and nutrient

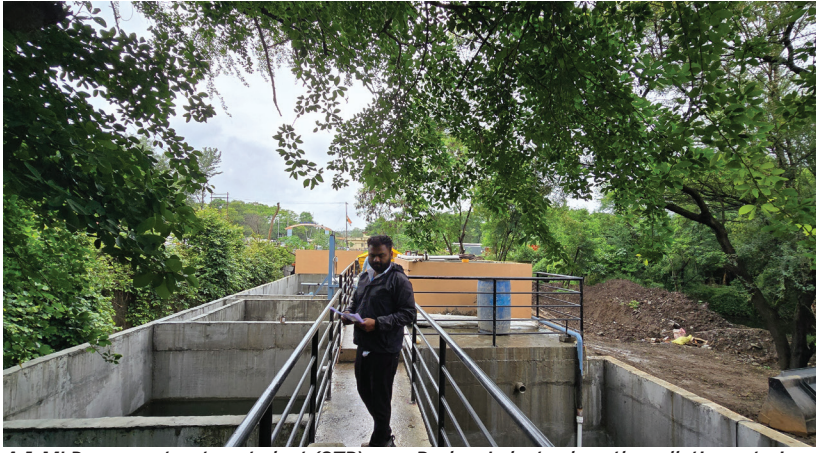
A 1-MLD sewage treatment plant (STP) near Pashan Lake to clean the pollution entering the lake

The STP has come up under the 15th Finance Commission. A budgetary provision of Rs 549 lakh was sanctioned, with the work order awarded to M/s Parshuram Construction Group. The project includes laying 1,380 metres of new sewer lines to divert sewage to the newly constructed 1-MLD sewage treatment plant. The total cost of STP construction

is Rs 4.98 crore, with an additional Rs 50.7 lakh earmarked for three years of maintenance and Rs 4.89 lakh for material testing and royalty. The plant is designed to treat sewage with influent BOD of 250 mg/L, COD of 400 mg/L and TSS of 350 mg/L, using IFAS (Integrated Fixed-Film Activated Sludge) technology, ensuring treated water meets stringent NGT norms, including BOD <10 mg/L, COD <50 mg/L, TSS <20 mg/L, and faecal coliform <100 MPN/100 ml. The treatment process includes coarse and fine screening, grit removal, equalization, anoxic and IFAS biological treatment, tube settler clarification and chlorination, with the final treated water stored for recharging the lake and reuse in gardening and construction. Additional components include repairing the right bank wastewater channel and manholes along the Ram River and stopping direct sewage discharge into the river. Overall, the project will significantly reduce pollution in the Ram River, improve lake water quality, and reduce the foul odour in the surrounding areas while ensuring sustainable reuse of treated wastewater.

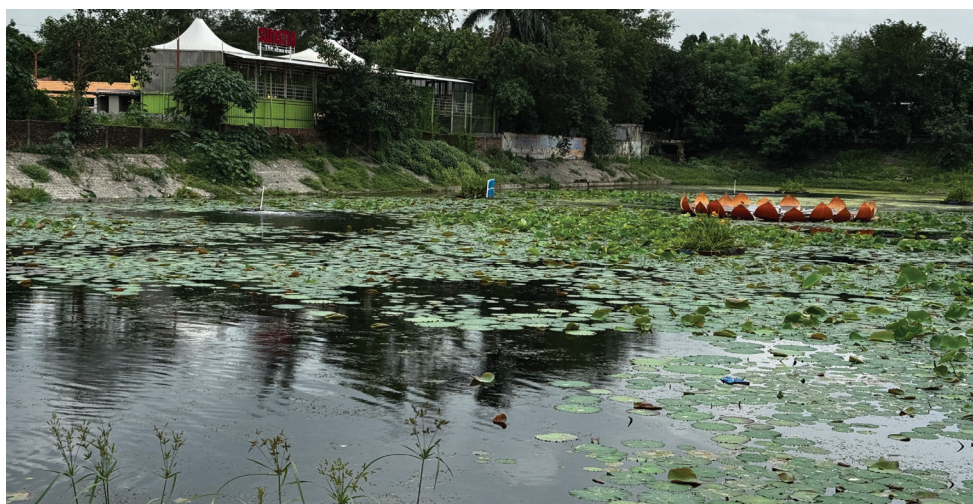
Annapurna Lake with a floating solar lotus aerator

To restore the deteriorated Annapurna Lake, a focused and science-based rejuvenation plan was implemented. The process began with a detailed assessment of water quality and ecological conditions following fish die-off in 2023, which highlighted issues such as high nutrient levels, low dissolved oxygen, sludge accumulation and invasive vegetation.

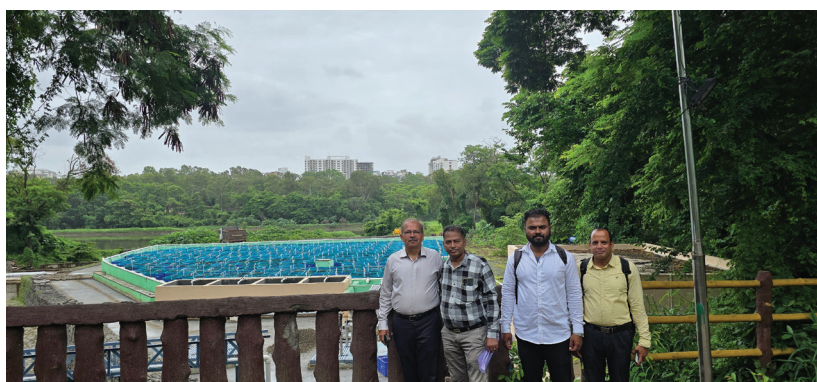
A Tiger Biofilter-Based Technology treatment plant has been installed to treat sewage before releasing into Katraj Lake

The Corporation has undertaken a major rejuvenation initiative to restore lower Katraj Lake, an ecologically significant 29-acre waterbody located within Rajiv Gandhi Zoological Park. Years of urbanization and uncontrolled sewage inflow from Santosh Nagar, Katraj Vasahat and Rajas Society had severely deteriorated the lake's water quality, evidenced by elevated BOD (14.76 mg/L), COD (29.18 mg/L), high TDS (860 mg/L) and dense growth of water hyacinth.

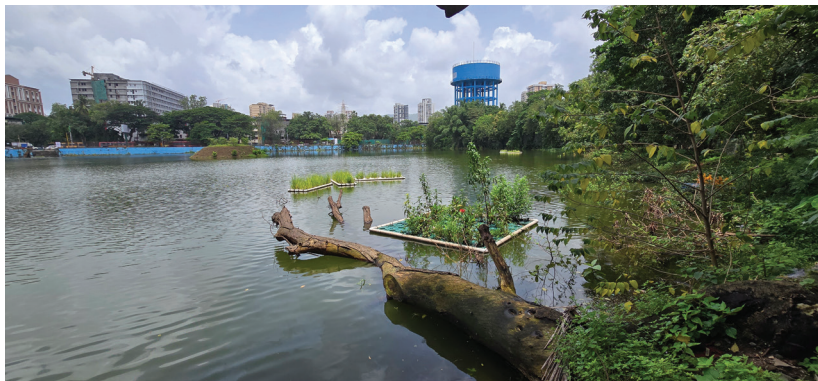
Floating islands installed in Jail Lake, Thane, to clean the lake

Another challenge that eventually cropped up was the leaking sewage network as the city network is old. Due to this the lake had odour issues. M/s Microbact Bio Culture, a Pune-based consultant was engaged to find a solution. They installed floating islands, with vetiver and wedelia plantations, and silt traps to treat incoming water and prevent future pollution. They also inject bio culture solutions twice a month, which helps faster degradation of organics in wastewater. The lake area also recorded wildlife sightings—snakes, squirrels, egrets, and kites—all of which were rescued safely and transferred to authorities. A temporary fish and

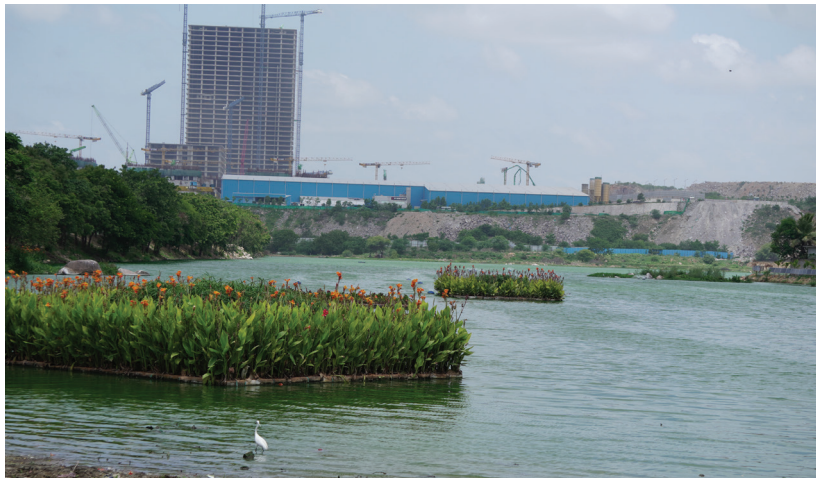
Floating wetlands installed in Kotha Cheruvu Lake

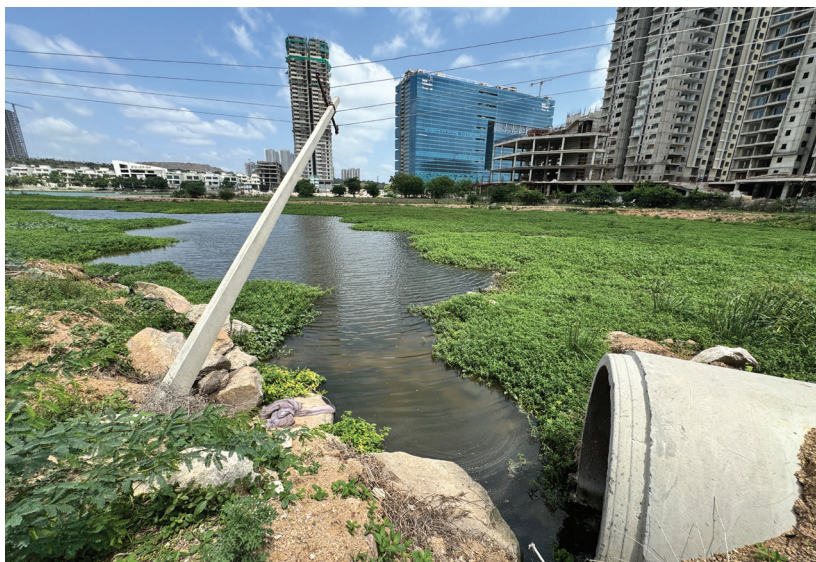
Entry of sewage into Kotha Cheruvu Lake

Increasing urbanization around this 72-acre lake led to encroachment of the lake area, discharge of untreated sewage, solid waste dumping, broken bunds and neglected flora and fauna near the lake. Around 25 MLD of untreated sewage from the surrounding residential area of Kokapet would enter the lake; 15 MLD of sewage entered the lake from a 15-MLD sewage treatment plant (STP) near the lake. The lake is owned by the Hyderabad Metropolitan Development Authority. It was given to Dhruvansh NGO for restoration.
